Survey Report of Submarine HMS A1

Martin Davies

Summer 2006

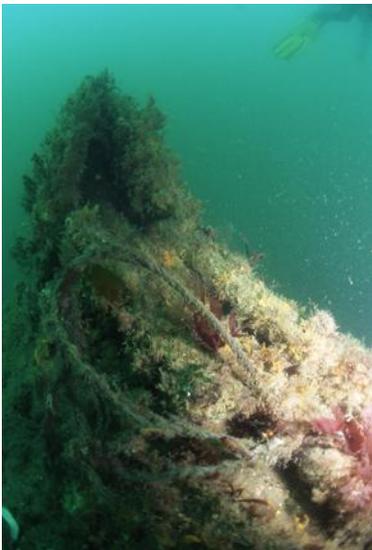
Photograph 2

This picture taken at the bow of HMS A1 shows the missing outer casing that has dissolved, a triangle is visible in the top right hand corner where the outer casing once connected, and this missing casing has exposed the drive gear for the forward torpedo tube.

A line is also visible that has been used in the past as part of a buoy system to mark the position of the wreck.

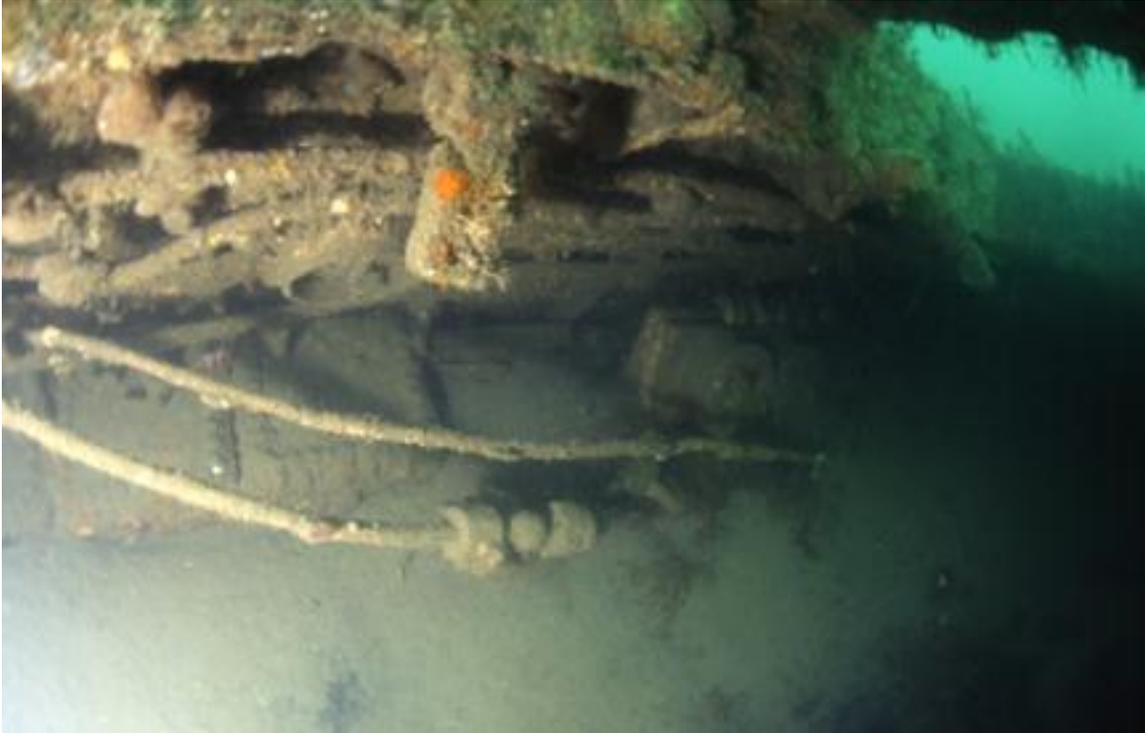
surrounding seabed, looking into the abyss you cannot distinguish much and even a torch beam does little penetrate into the darkness. Photograph 3 taken from inside gives some indication of the amount of sediment that has now filled in this area and also shows some of the mechanics of the submarine.

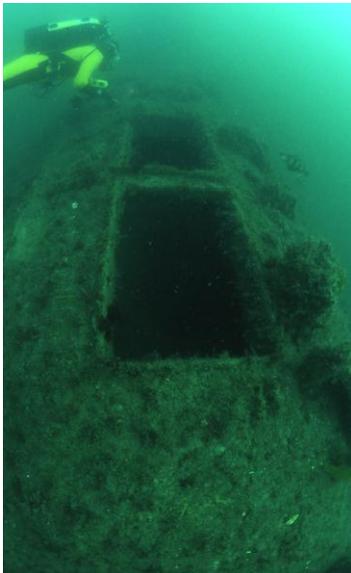
Photograph 4

Moving further along the pressure hull at the top of the wreck there are two open hatches, (see photograph 4). The three torpedo's would have been loaded through these hatches, their openness is evidence of human interference, whilst there is little to steal from inside the submarine it is an example of the curiosity that exists from some of the sports diving community. The hatches can be found on the seabed either side of the wreck (see photograph 4). Whilst the hatches have been off for many years this has allowed the vessel to slowly fill with mud and sediment from the

It can be clearly seen in photograph 4 the open hatches where the torpedos were once loaded

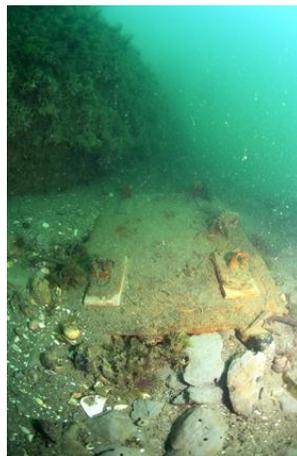
Photograph 5 clearly showing one of the hatches that has been removed and now resides on the starboard side of the vessel. It is not clear how these have been removed from the outside as they would normally closed and sealed from the inside. There are no obvious signs of force.

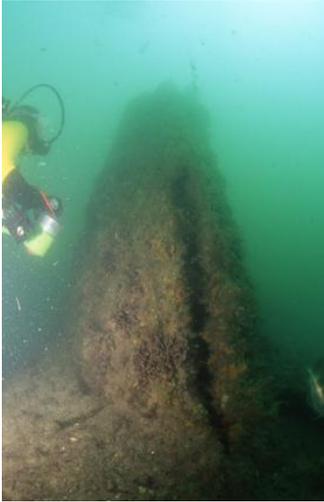
Photograph 6

In the amidships area the conning tower is still very much an identifiable part of the boat and can clearly be seen on an echo sounder trace as the proudest point of the site. There is a large crack that runs the height of the tower on the forward face and a smaller one on the rear see photographs 6 and 7.

The conning tower although easy recognizable still, is now showing signs of deterioration and fatigue, this will probably be the next thing to drop off in coming years.

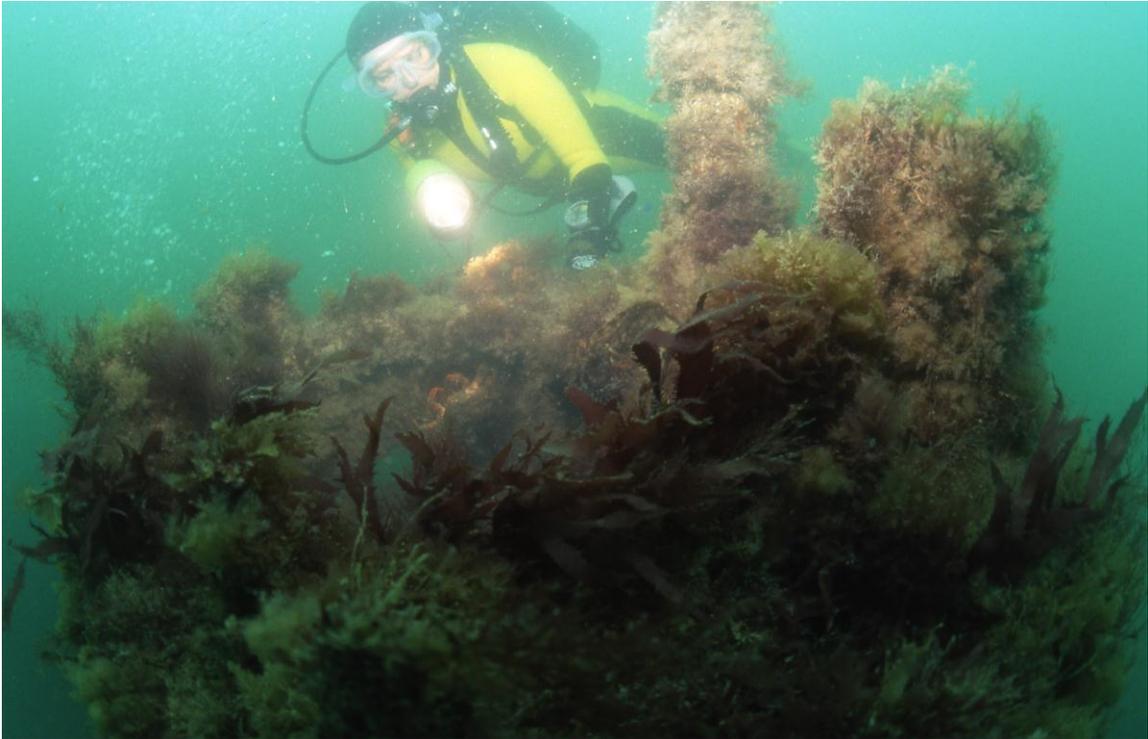
Looking at the upper part of the conning tower there appears to be only two out of the four tubes showing in one of the original photographs, it's difficult to ascertain what is left and what is missing. Photograph 8 shows what is left of the upper part of the tower, further investigation will be done over the following year to find out exactly what is left and what has disappeared. As you can see from the image below there is a lot of growth on the submarine and this makes identifying parts of the boat very difficult. A basic line drawing has been obtained from Gosport Submarine museum which was part of the original plans but no real detail can be ascertained from them.

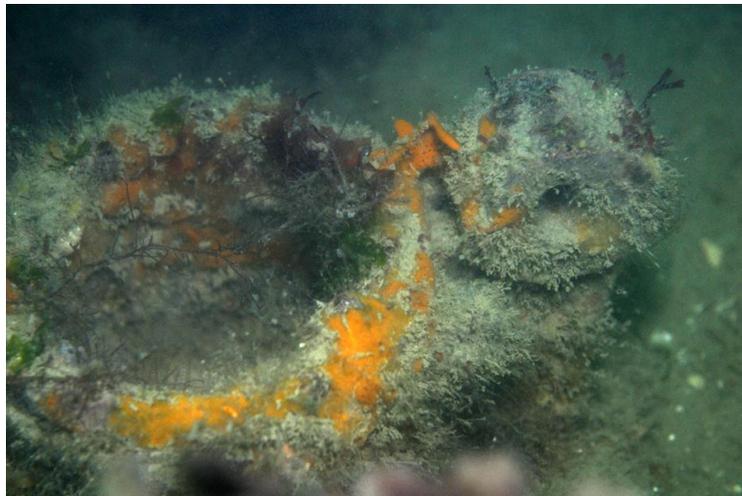
Photograph 9

Heading further towards the stern, again the outer casing is missing from the top of the boat; this has exposed a variety of fixtures and fittings. Some objects appear clearer than others, there are several intakes showing, photograph 9 shows one of the fuel filler or water filler intakes.

Here it can be clearly seen that one of the intakes to the boat has lost its cap, although they could have rotted away, it is more likely that they have been salvaged at some point in the wreck's history.

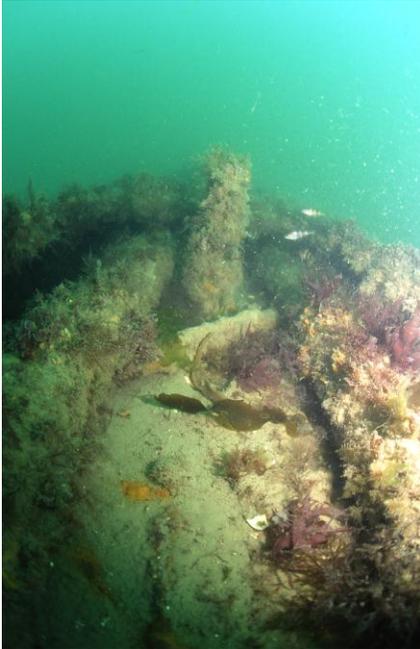
Photograph 10

In photograph 10 two long tubes can be clearly identified, these are almost certainly part of the exhaust system for the Wolseley 350Hp petrol engine, they are very similar to the ones that can be seen on Holland 1, what is missing or burred is the exhaust box. At this point the submarine starts to disappear into the seabed.

The two pipes that can be seen in the picture are about 10feet long running along the length of the wreck. In the middle the upright may have been a small bollard. The exterior compass is missing too. An alternative theory is that this upright was used to support periscope guide wires as used on Holland 1 but this is less likely as the conning tower on A1 did most of the structural supporting for the periscope. And the guide wires that appear in one of the original pictures of the submarine appear to secure further back beyond the lifting strops.

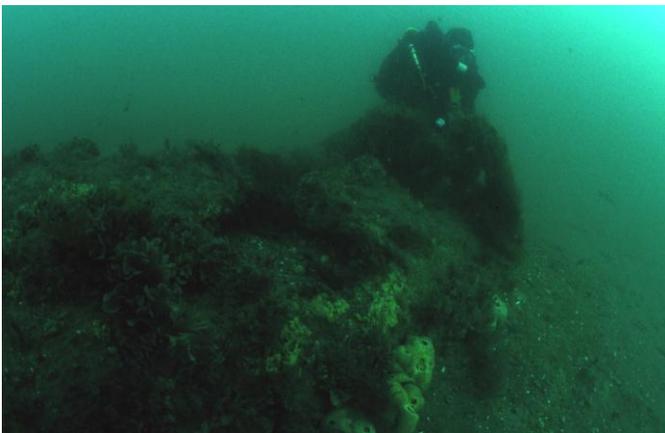
Photograph 11

At the rear of the boat things are not so clear, photograph 11 shows how the boat comes to an abrupt end, the last recognizable feature is the lifting strop which for some reason were never taken off the boat when it went into

service or they were an integral part of the design of boats of that era, either way they are substantial pieces of ferrous material. In the middle of the image a rectangle can be made out, this possibly was where the exhaust box was fitted and again requires some further investigation next season.

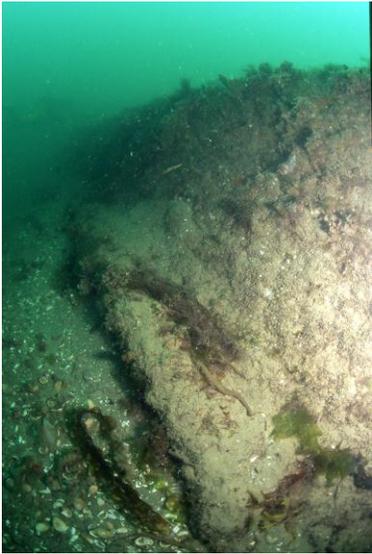
Beyond this lifting strop there is nothing but muddy seabed, the boat comes to abrupt end, you expect to see a rudder, hydroplanes and a propeller, but there is no evidence of their existence, it is a little odd considering the completeness of the rest of the wreck. Photograph 12 shown how the stern of the boat disappears into the muddy depths of the seabed and so it is not possible to establish what, if any thing is remaining of the stern section, where the rudder and propeller should be. Detailed measurements need to be taken next season to get an idea of just how much of the wreck is buried and also how deeply it is buried.

The bulges on the side of the hull could give some indication of what is remaining in the seabed though they are not shown on the scale drawing.

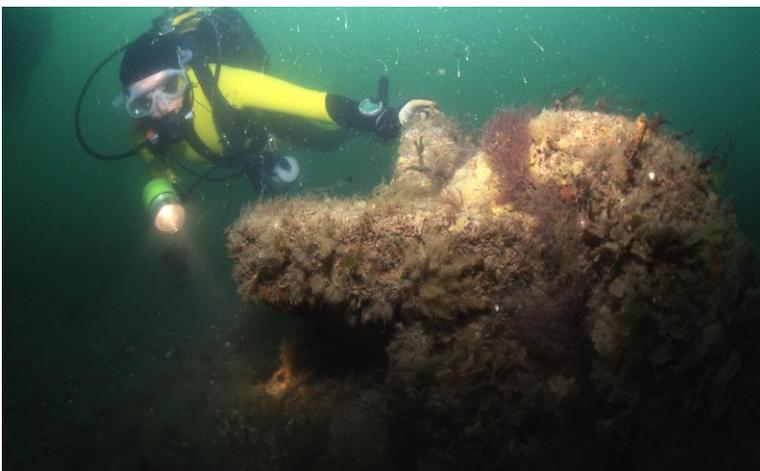
Photograph 13

The last visible remains of the boat can be seen in this picture.

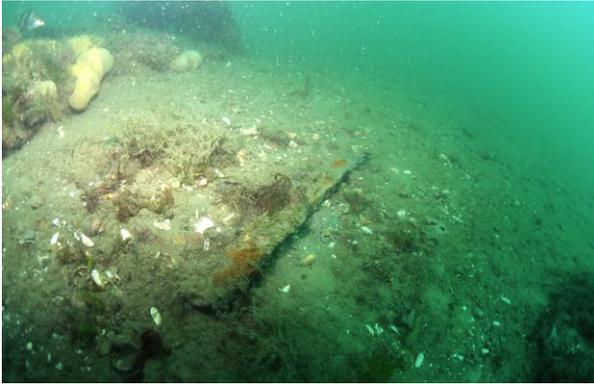
Photograph 14

In the middle of the picture here is seen a straight piece of metal near the stern area on the Port side. Its origins are unknown at this point in time.

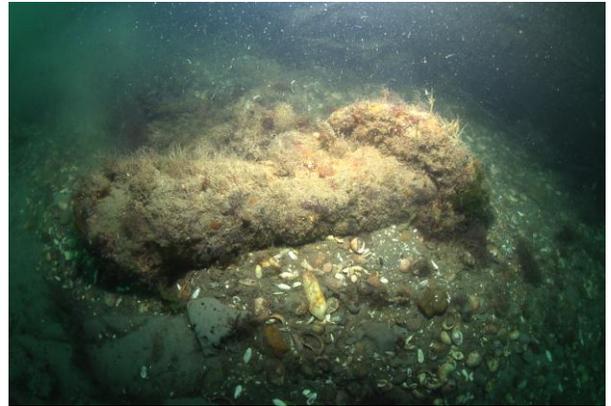
Photograph 15

Near the bow is this large lump of material, it looks a bit like a bollard but this is unlikely as submarines of that era were not fitted with such fittings. Further investigation will be required to fully establish what it is.
