TWO TUGS

Report of the investigation of WW2 wrecks reported to be HMRT SESAME and USS PARTRIDGE, Baie de Seine, Normandy, France

> Southsea Sub-Aqua Club | BSAC Branch 0009 December 2019

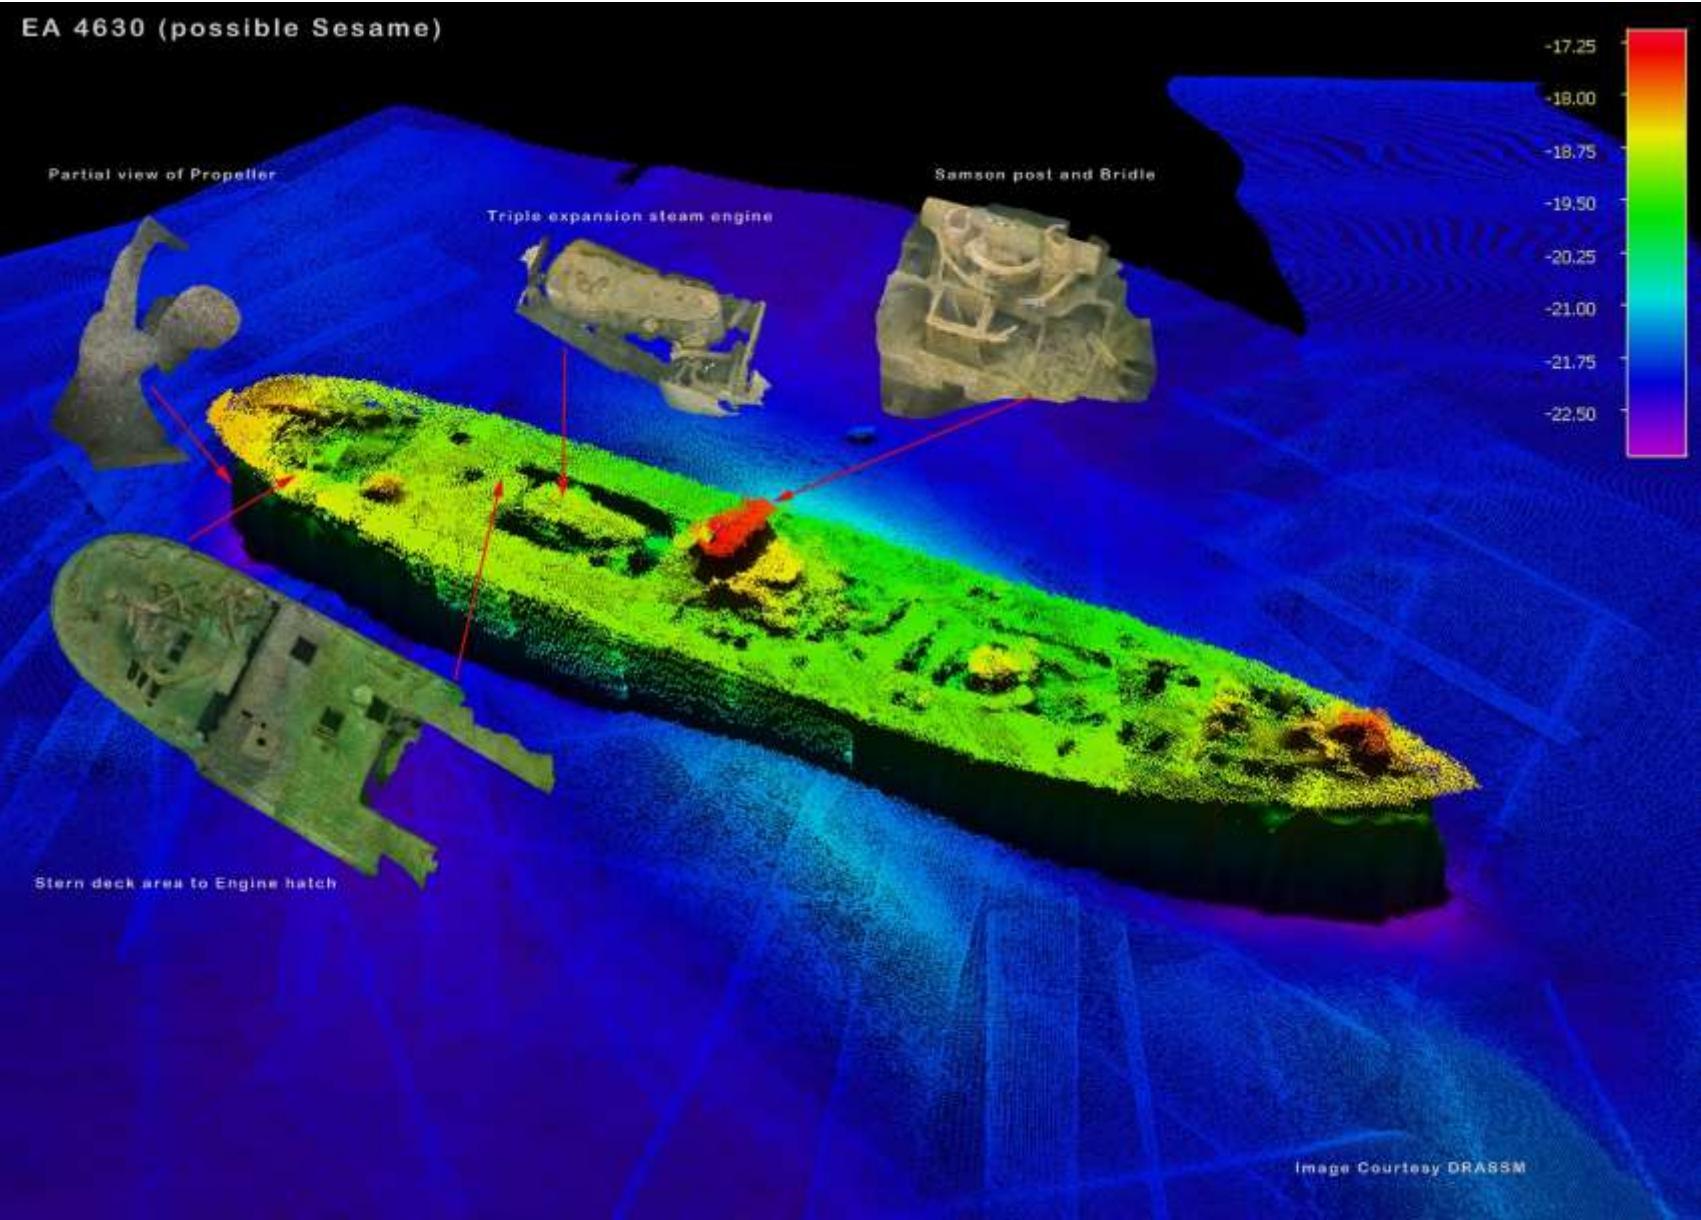
Figure 15 Multibeam image annotated with key features observed on the wreck. (© DRASSM and Martin Davies)

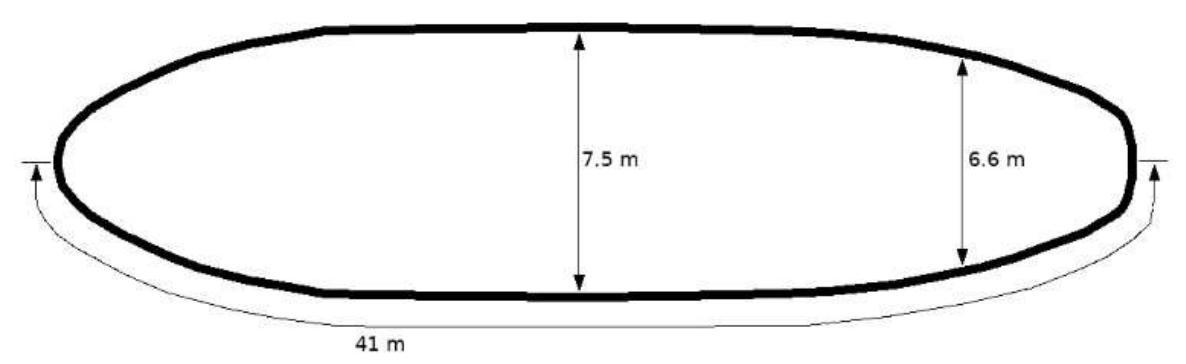
A direct measurement from bow to stern was not practicable due to the towing stanchion and forward winch assembly, which obstructed the ability to measure accurately. In order to overcome this two divers measured from bow to stern on the outer edge of the deck or gunwale. The length measurement was **41m** (134 feet 6 inches). In addition, the beam of the wreck, close to the towing stanchion and estimated to be the widest part of the wreck was measured. The beam measurement was **7.5m** (24 feet 7 inches).

Figure 16 EA4630 Wreck hull measurements (© Jim Fuller)

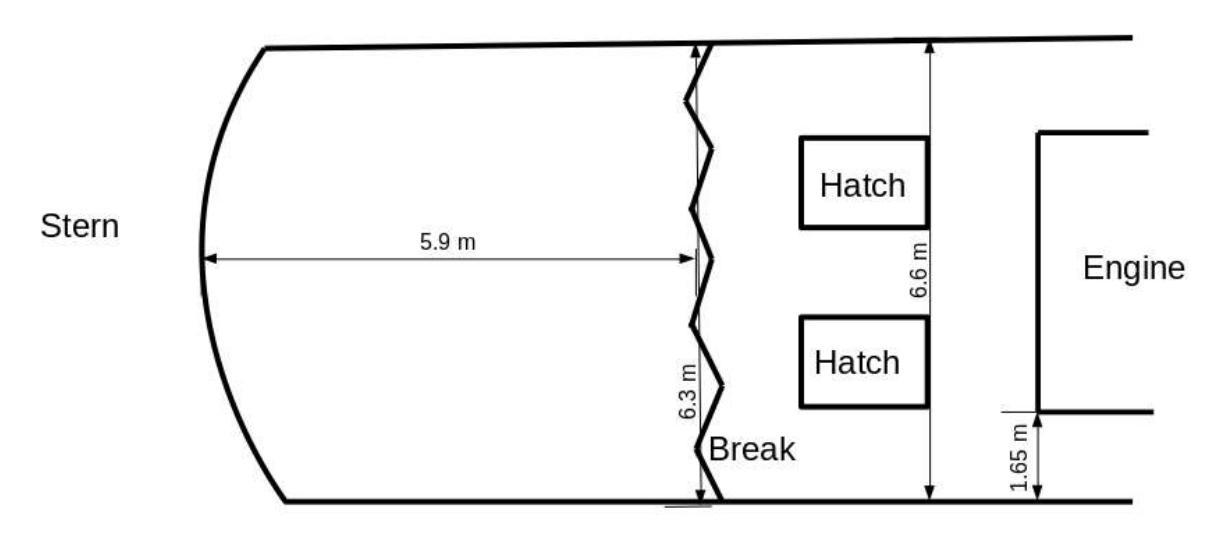
Further measurements and observations were recorded from the engine bay to the stern. It was noted that the wreck had a break in the structure, which was approximately 6m from the stern extending across the width of the deck (6.3m) and partially down the starboard side of the ship.

The width of the wreck across the deck behind the engine bay was **6.6m** (21 feet 8 inches) indicating a tapering stern.

Figure 17 EA4630 Survey data from the stern area. (© Jim Fuller)

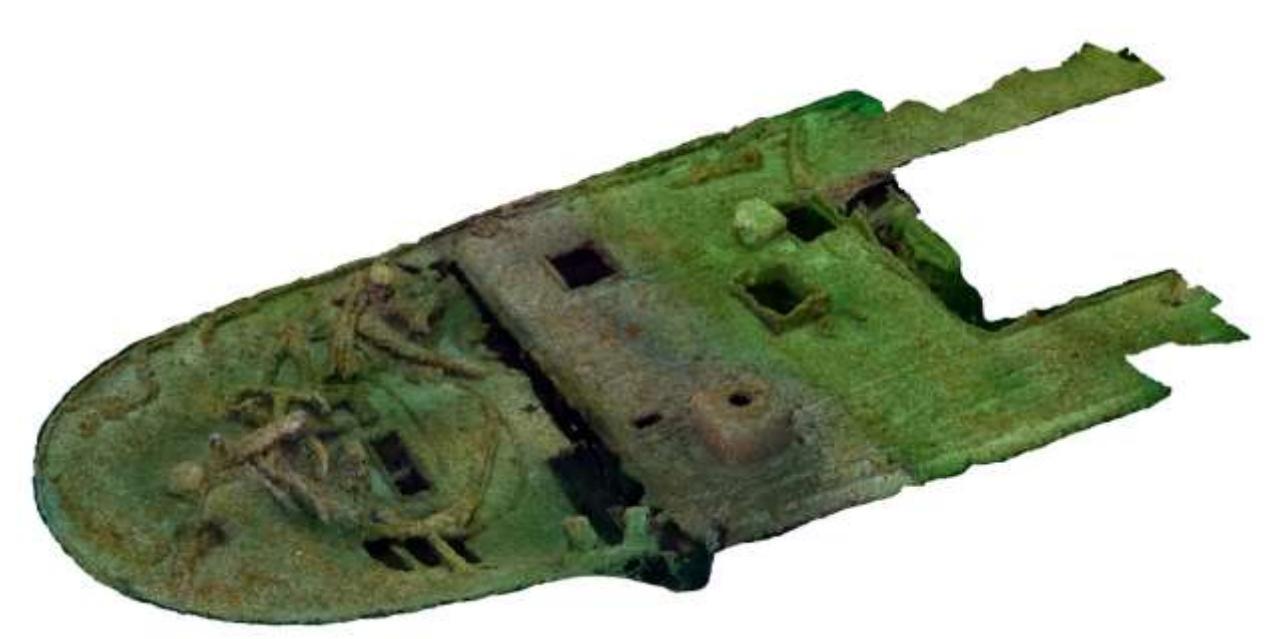
Figure 20 EA4360 Image created from photogrammetry model -Stern from the starboard side showing the collapse of the deck area. (© Martin Davies)

The top of the rudder post and steering quadrant were observed together with an anchor and rope. The damage to the starboard side at the top of the hull was significant, but we could not determine whether this had occurred at the time of the sinking or afterwards. However, given the intact condition of the wreck elsewhere, and this being the only evidence of a breach in the hull's integrity, it may be that the damage was a contributory factor to the sinking.

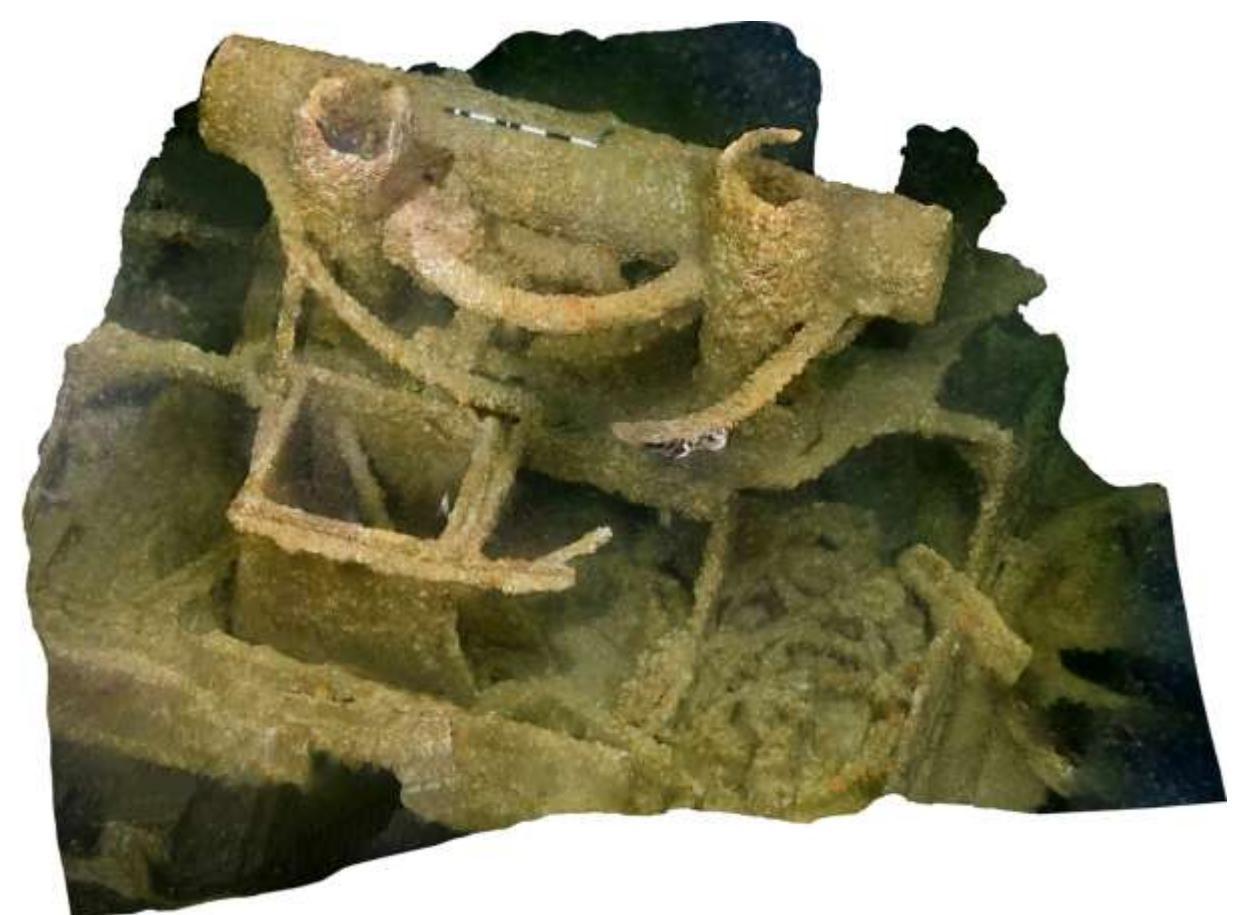
Measurements of the stanchion were taken, which aligned with the data from the previous DRASSM survey data. Part of the rope guide has broken, but otherwise the stanchion remains intact.

Figure 23 EA4360 Image from photogrammetry model. Towing stanchion from port looking forward. (© Martin Davies)

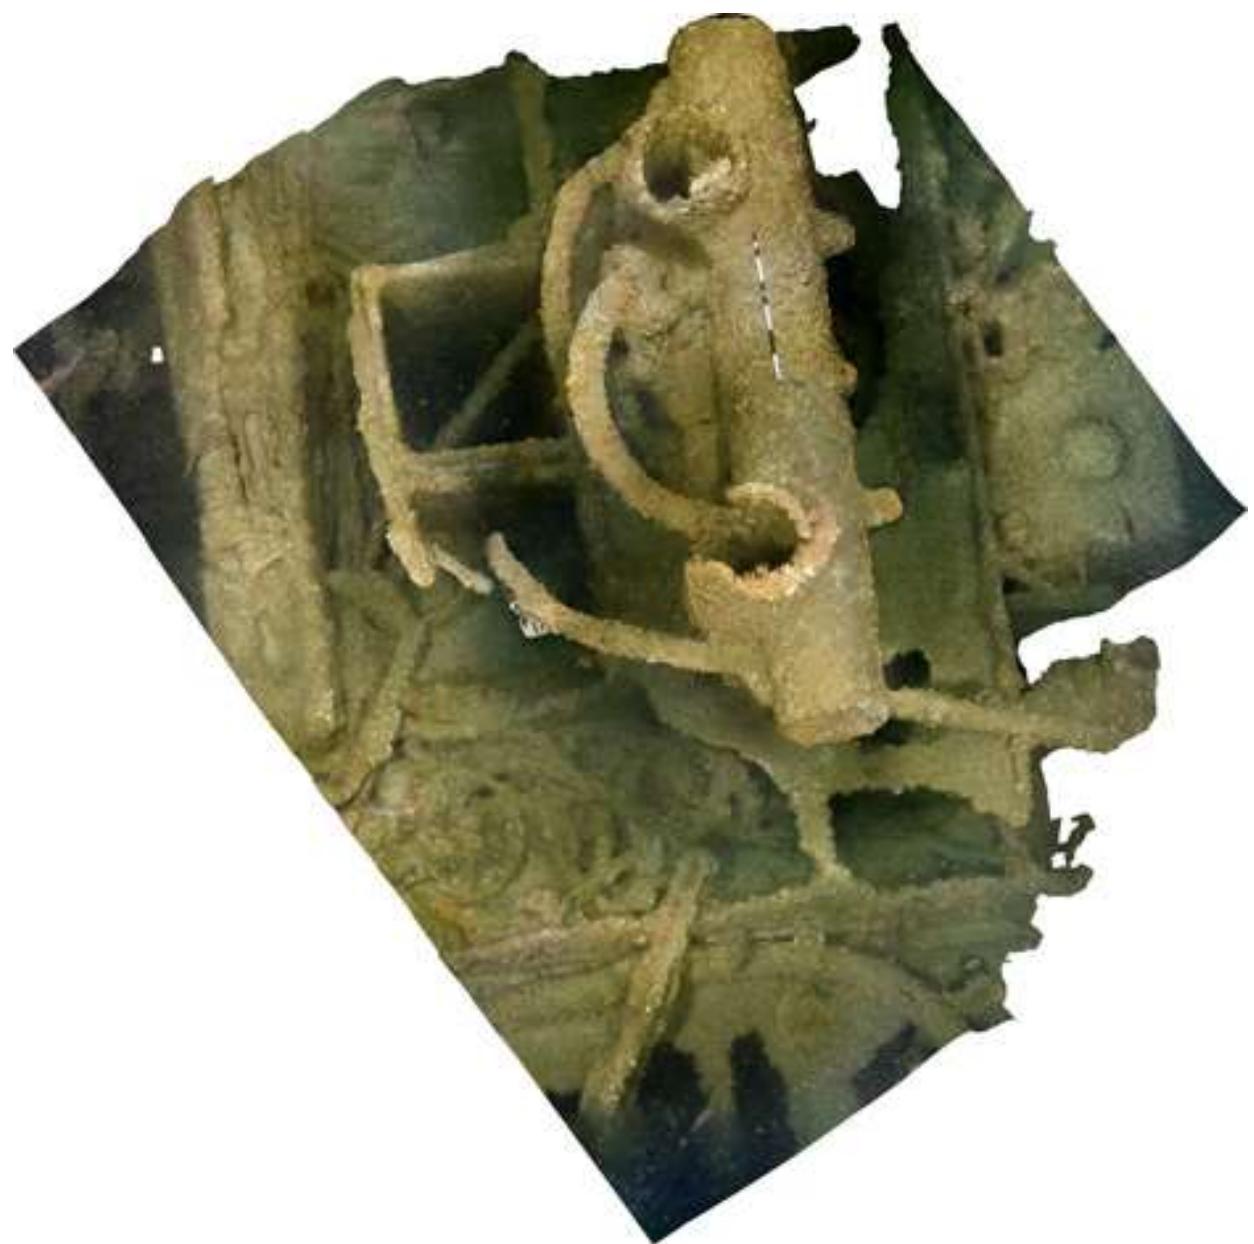
Figure 24 EA4360 Image from photogrammetry model. View looking down at the towing stanchion. (© Martin Davies).

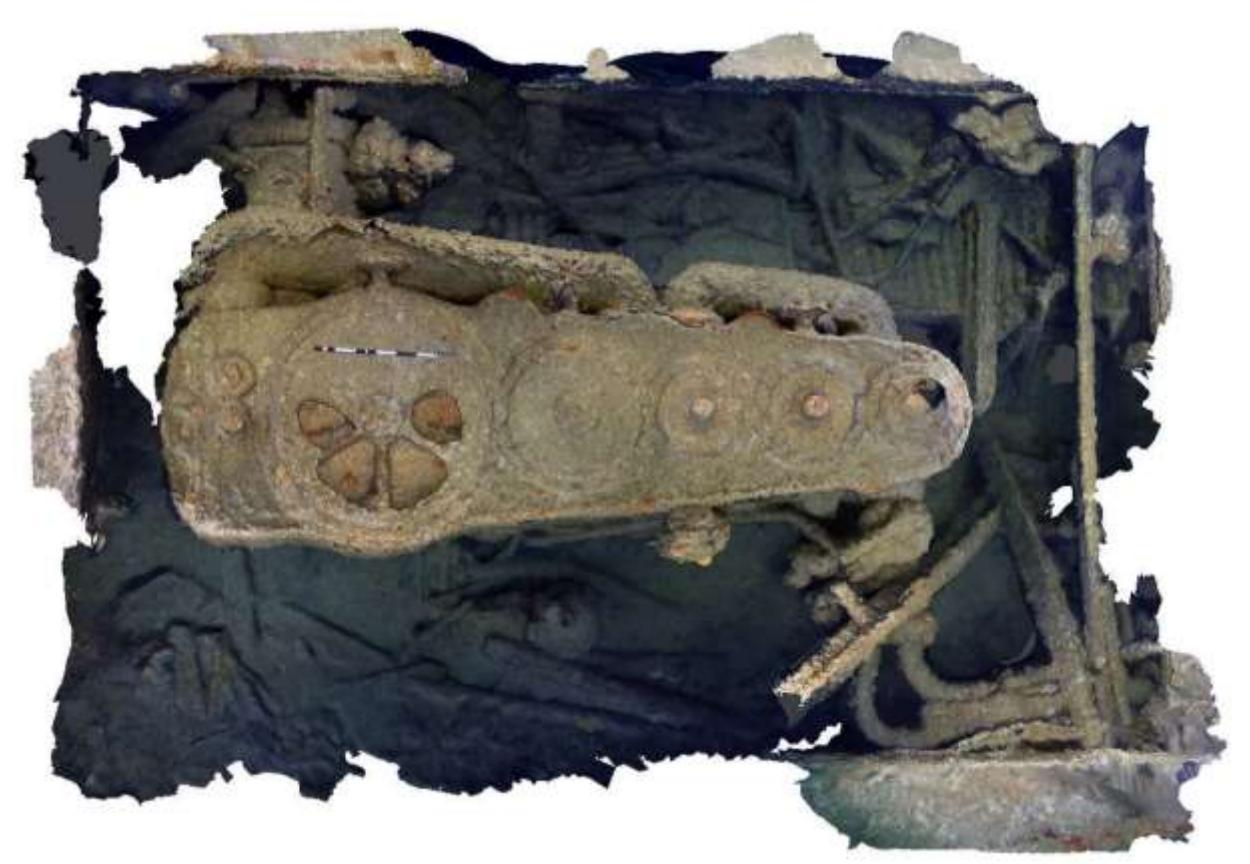
The propulsion system indicated that the vessel was a steam powered tug. Part of the boiler was observed, but was mostly covered by deck and the towing stanchion. There was no evidence of coal so the assumption is that the fuel used to heat the boiler was oil/diesel.

It is believed that the measurements 1 and 3 are of the steam expansion chambers. Measurement for 2, 4 and 5 represent the piston cylinder heads. Whilst the measurements of the largest cylinders are very similar, it is noted that there are some differences in the smaller measurements.

Figure 28 EA4360 Image of engine created from a photogrammetry model. (© Martin Davies)

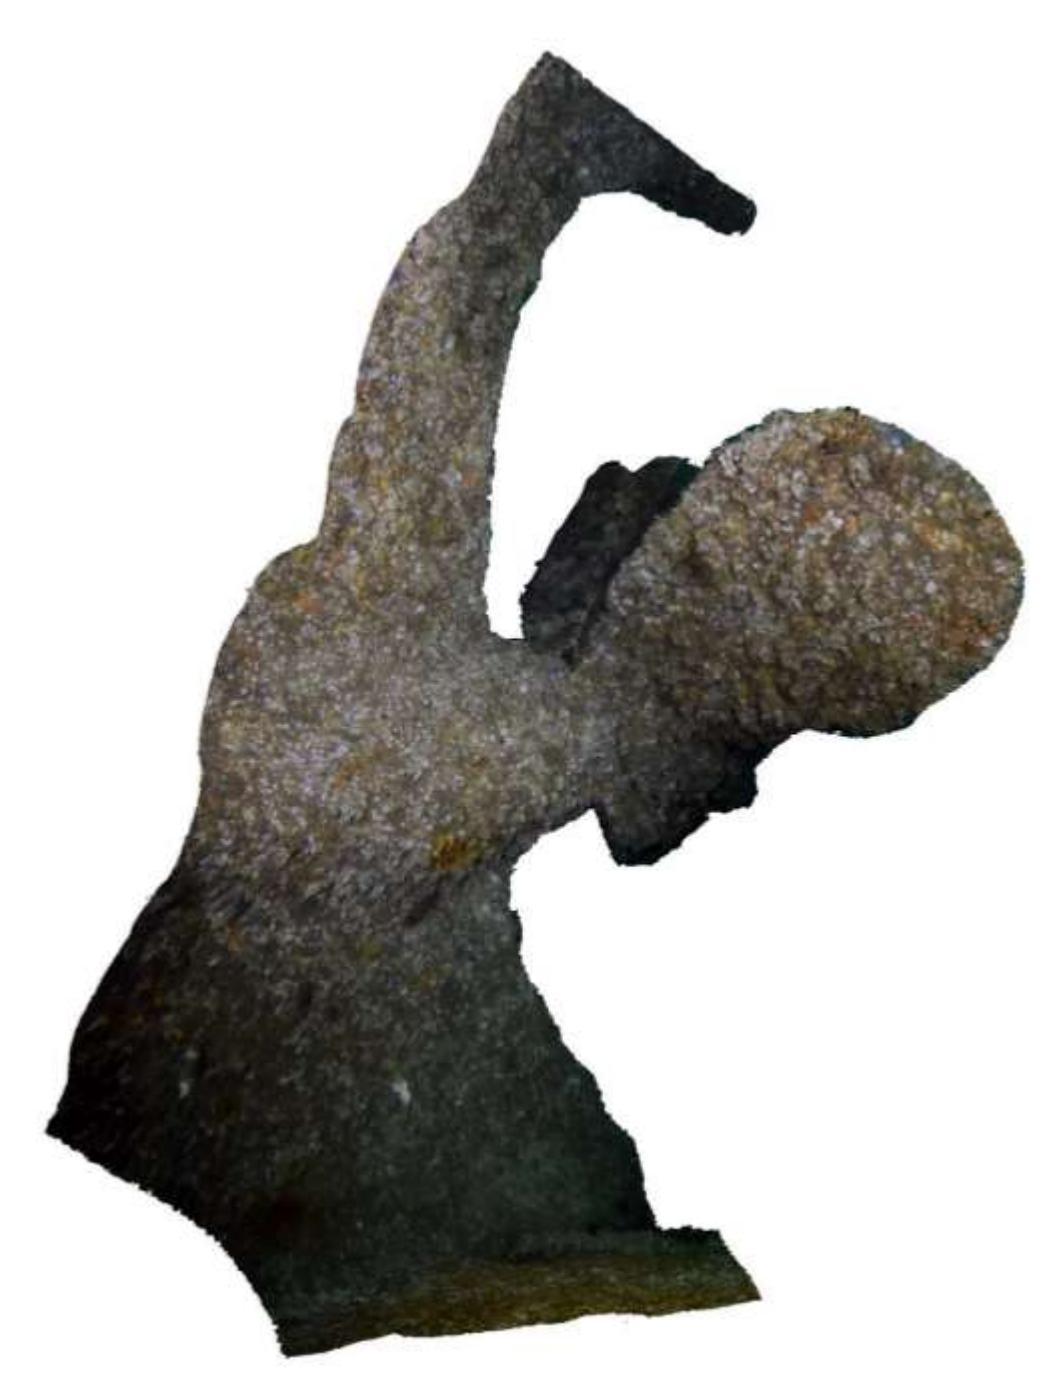
The iron propeller is in situ on the wreck, however one or more of the propeller blades is missing. The propeller was measured during the survey.

It should be noted that it was not possible to measure between the tips of the blades exactly. A variation of less than 60mm between the tips would have yielded a more exact result of 90 degrees. If the propeller had been three bladed the distance between the tips would have been approximately 2.39m, i.e. more than 0.5m greater than the observed measurements. Thus the conclusion is that the propeller would have originally had four blades.

Figure 30 EA4360 Image from a partial photogrammetry model of the propeller. (© Martin Davies)

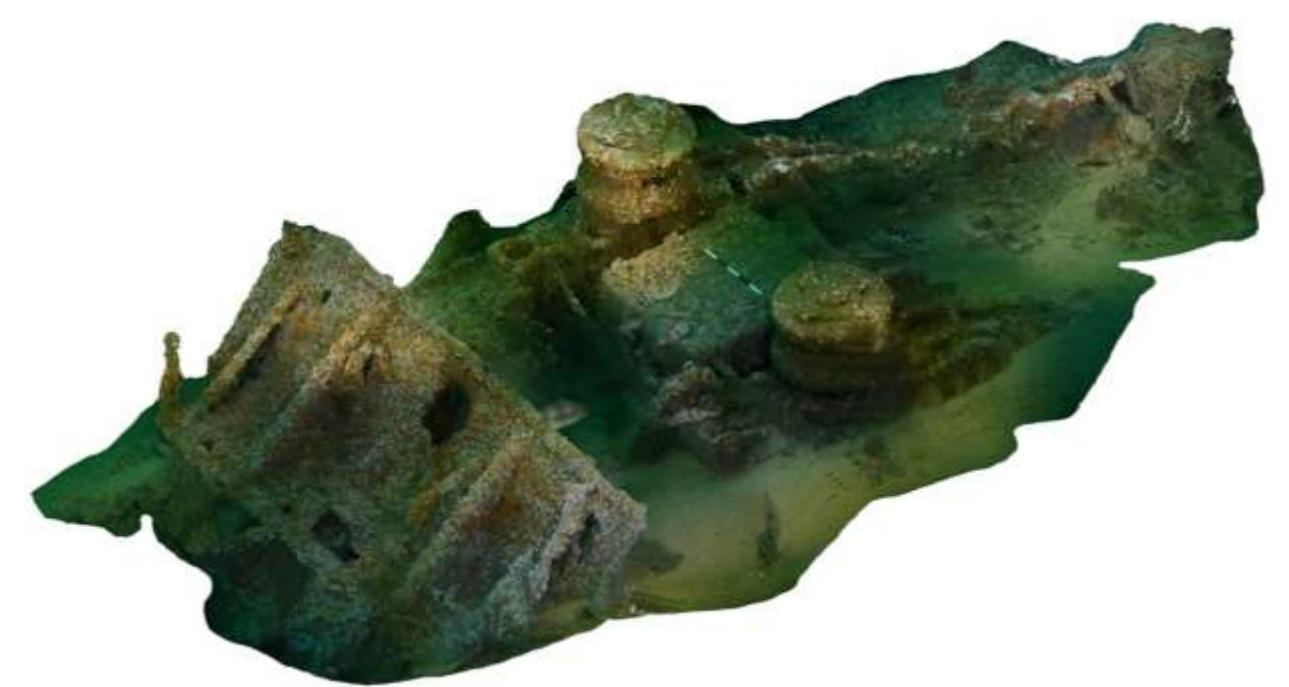
The bow is the most complete section of the ship and rests on its starboard side. On the deck behind the bow we observed a windlass anchor winch with vertical capstans. The chain to the port anchor was visible and extended down the hawser to the anchor.

Figure 41 EA3234 Photogrammetry image of the bow deck area note the vertical windlass capstans, port anchor chain and break-water. (© Martin Davies)

Observation 3 - There is no gunwale present on the wreck. However, a breakwater shield was found to be present behind the anchor winch.

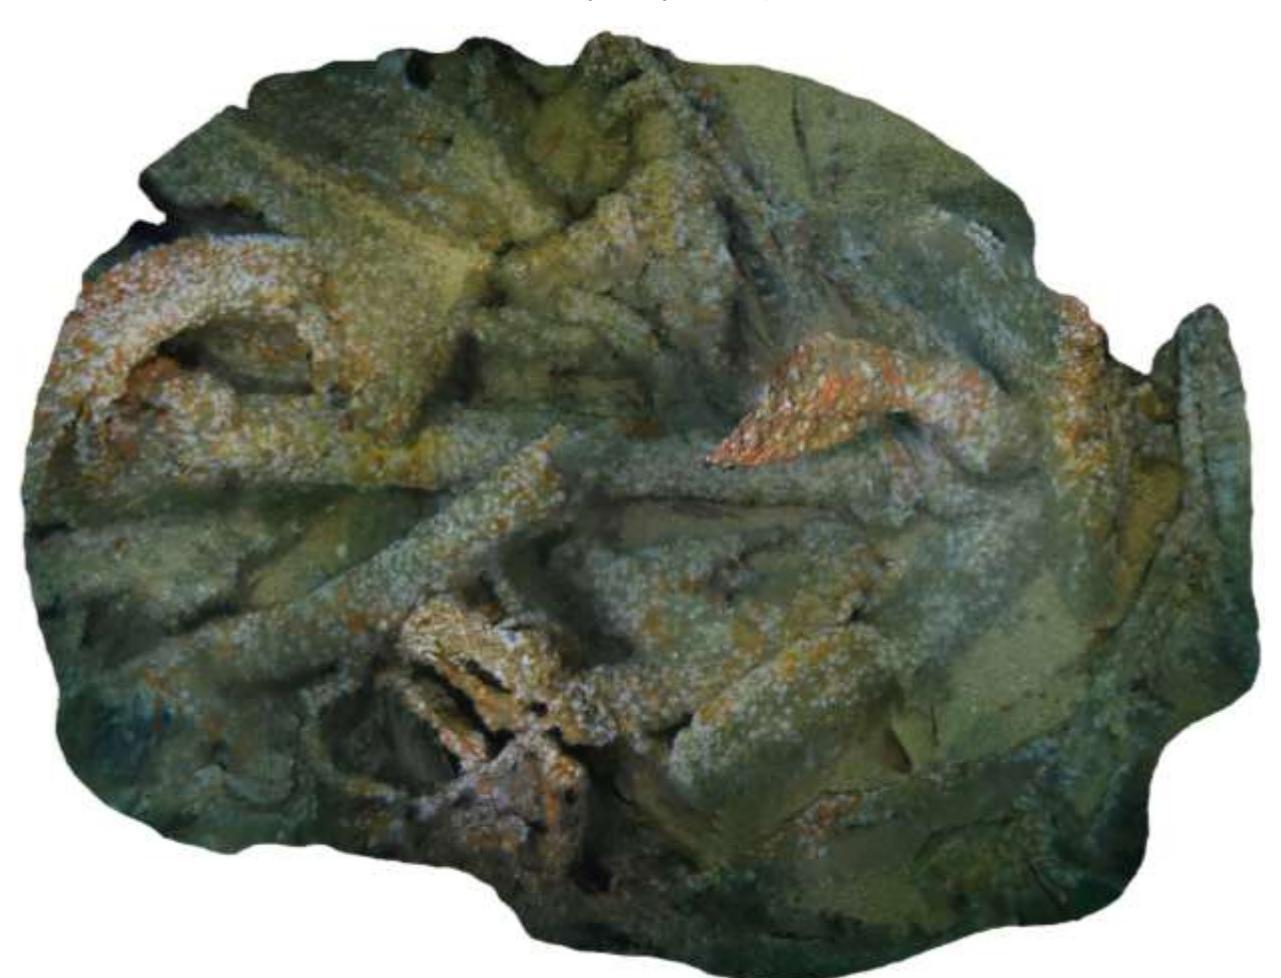
Figure 43 EA3234 the stockless anchor on the port side with the top of the shank entering the hawser (left) and the crown (base) of the anchor to the right (© Martin Davies)

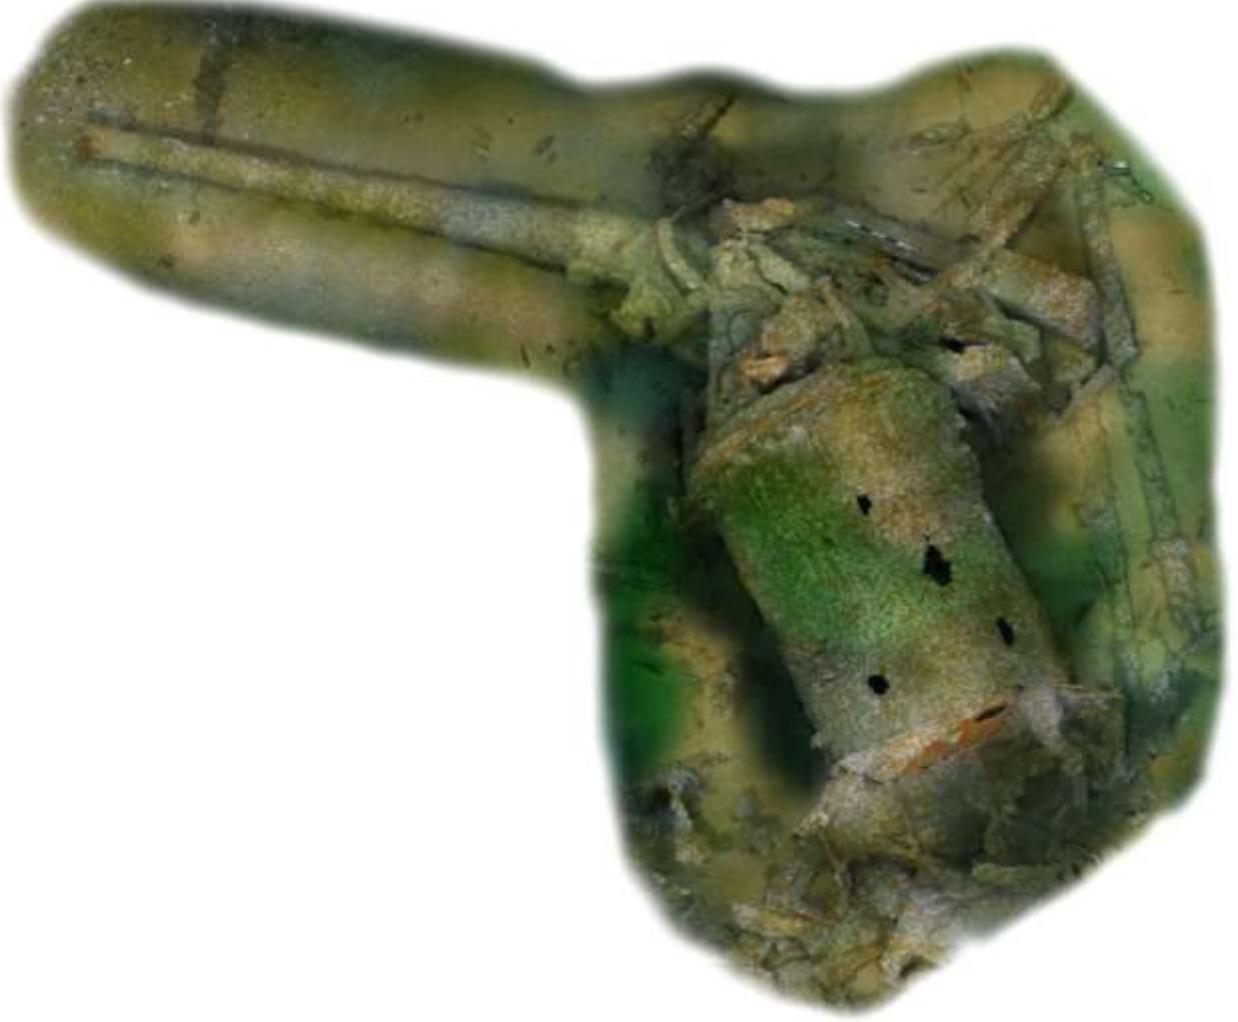
A total of three breach loading guns were found on the site; two guns behind the bow and one after the boiler section to the west.

Figure 44 EA3234 Image taken from photogrammetry model of Gun 1. (© Martin Davies)

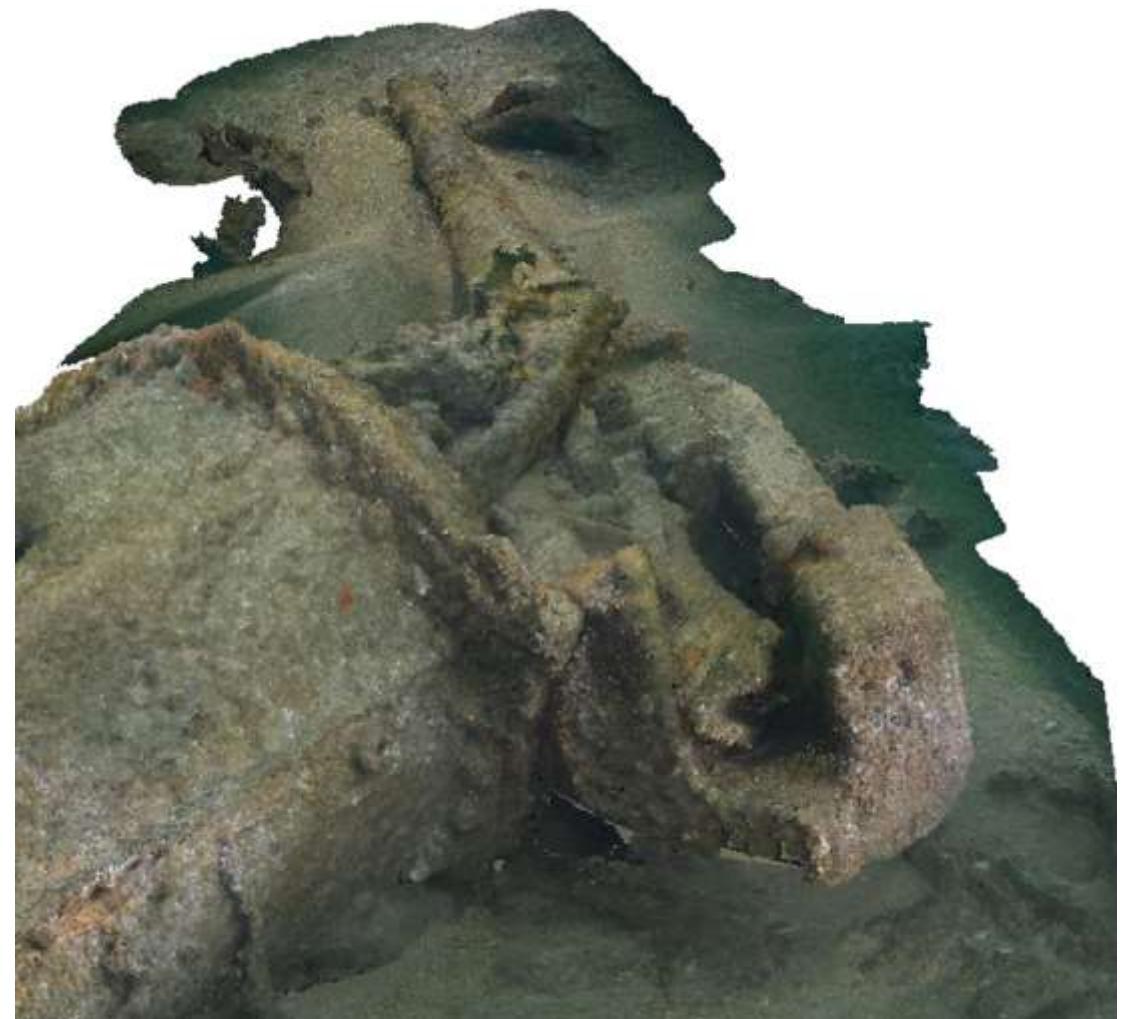
Figure 46 EA3234 Photogrammetry image of Gun 3 and breech mechanism. (© Martin Davies)

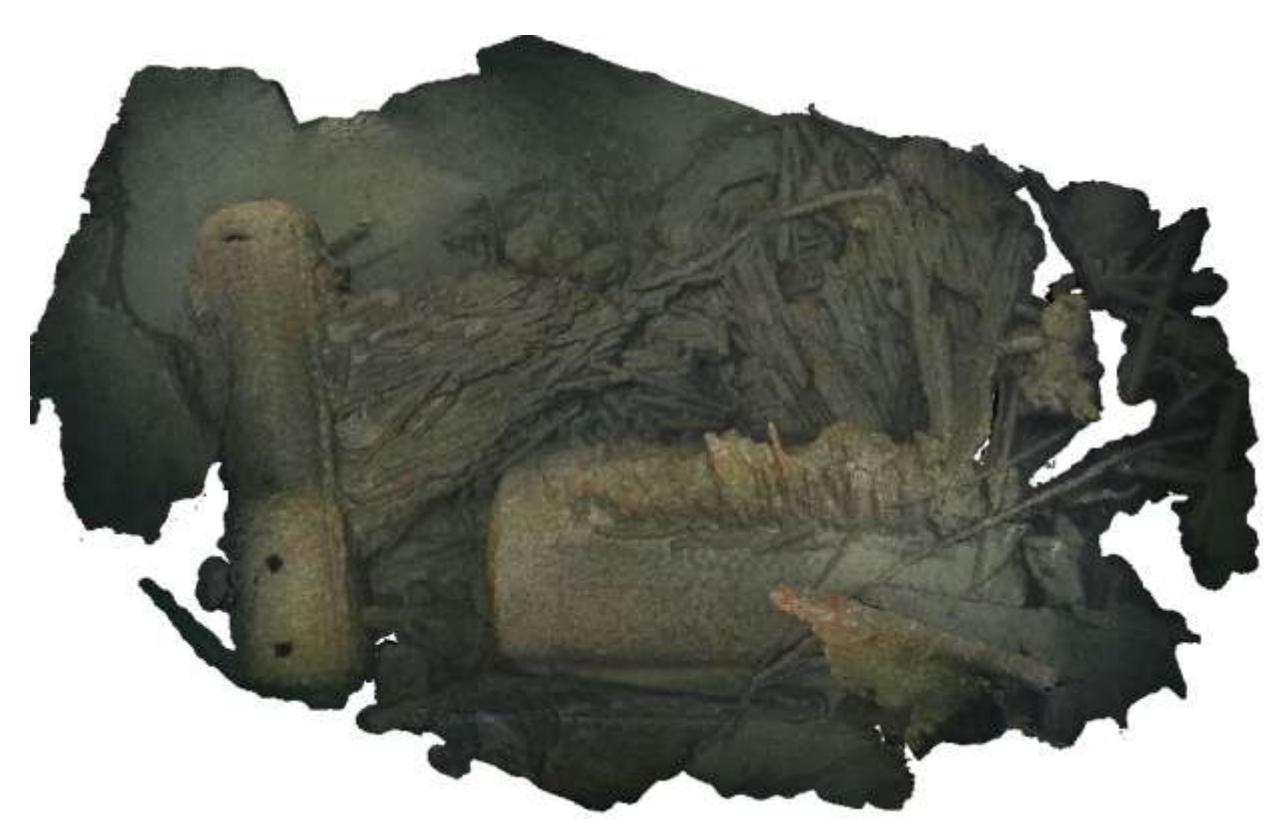
The highest part of the wreck is where the remains of the ship's steam boilers are located. We observed two cylinders surrounded by many lengths of broken pipes. The larger of the two cylinders had pipes extending vertically and the other, smaller cylinder, on its side, had pipes that extended horizontally. The boiler assemblage was very broken possibly as a result of salvage activity.

Figure 50 EA3234 Photogrammetry image of boiler debris - larger cylinder (steam drum) and smaller cylinder (water drum). (© Martin Davies)

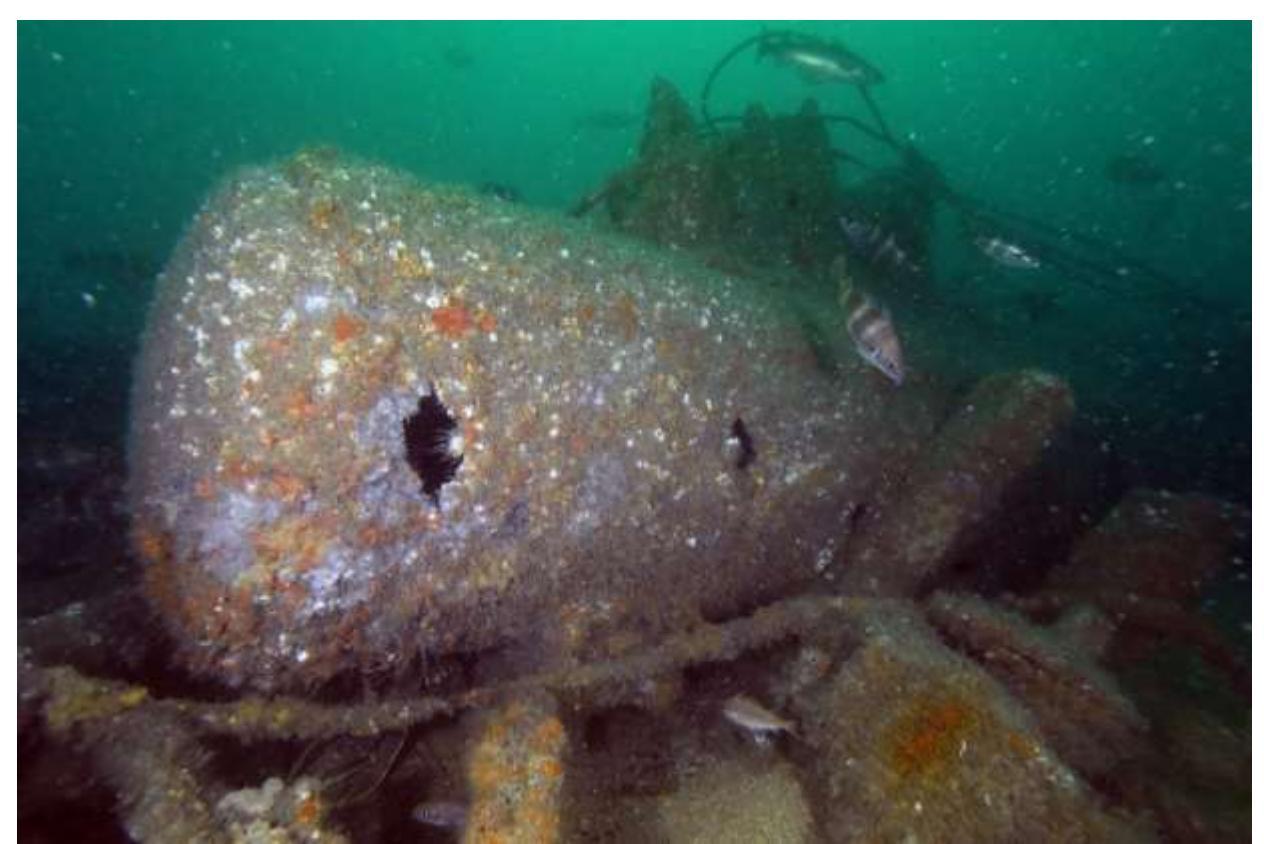
Figure 51 EA3234 the larger boiler steam cylinder with pipes extending vertically. (© Martin Davies)

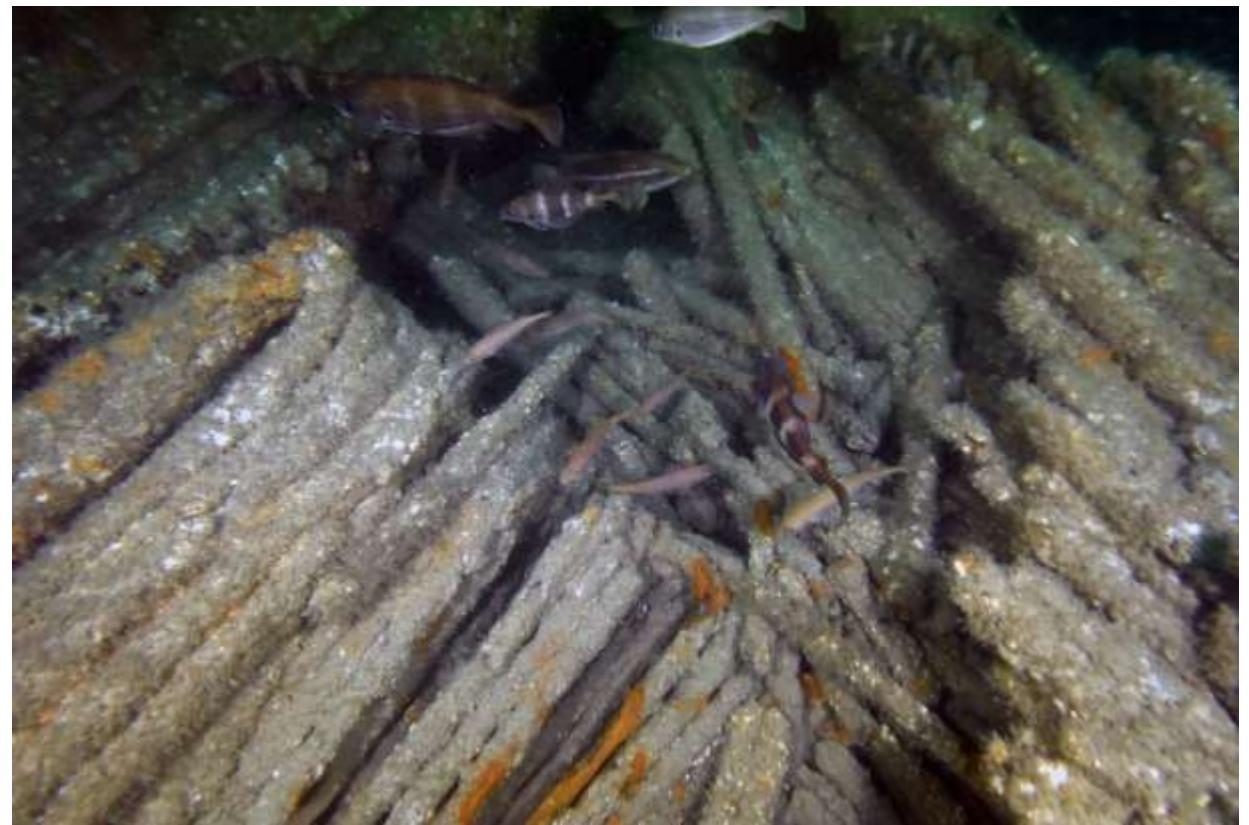
Figure 53 EA3234 a large amount of broken boiler pipes. (© Martin Davies)

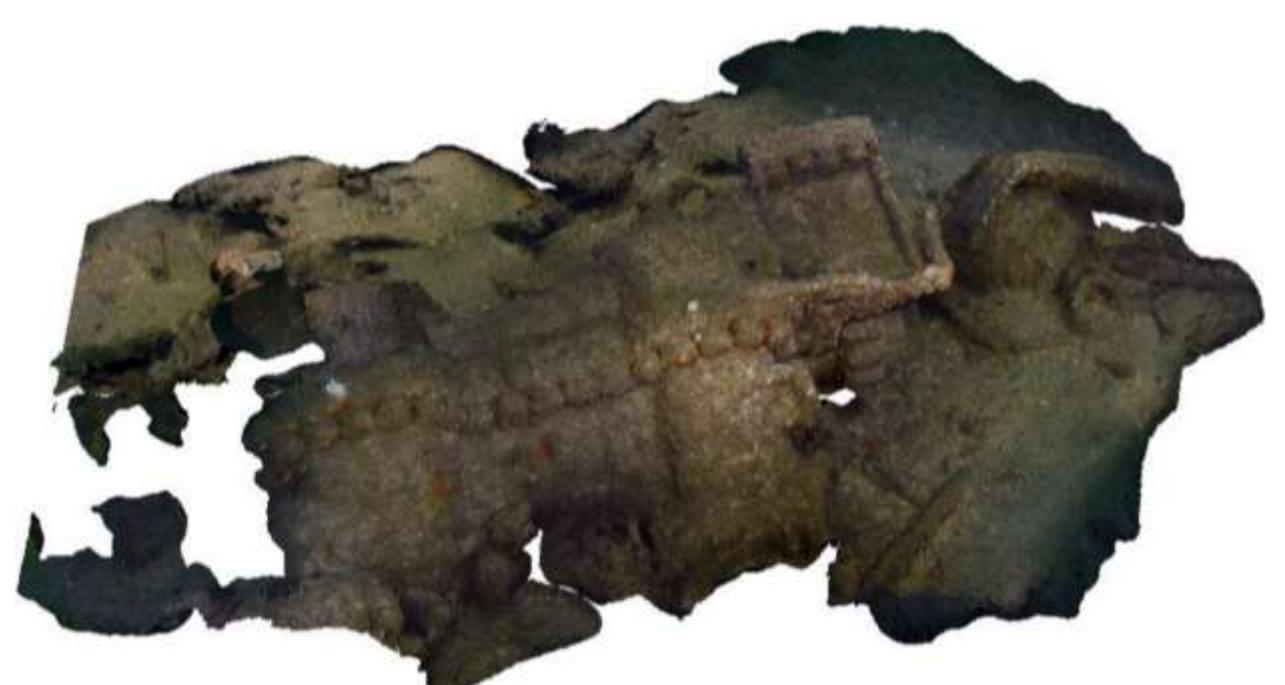
We also noted the presence of what appeared to be a part of a turbine assembly to the North of the boilers.

Figure 56 EA3234 Photogrammetry of a section of the probable turbine system. (© Martin Davies)

Observation 7: We did not find evidence of a triple expansion engine. However it is noted that the site has been subject to commercial salvage and this may explain why an engine was not found.

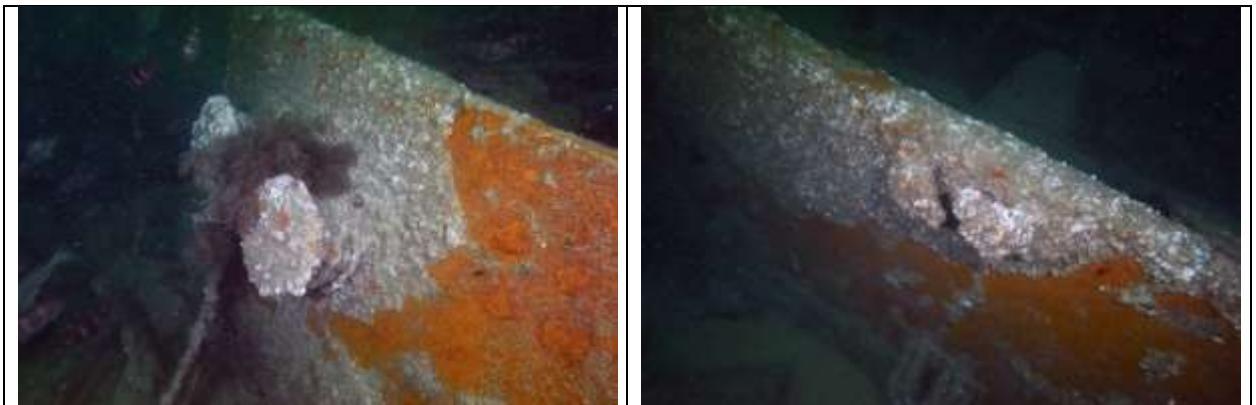
The area is bounded on one side by a length of port side deck or bulwark³³, complete with bollards. In this area we also observed the remains of a fishing trawler's gear and net.

Figure 57 EA3234 Port Bulwark - Bollards and Fairlead (© Martin Davies)

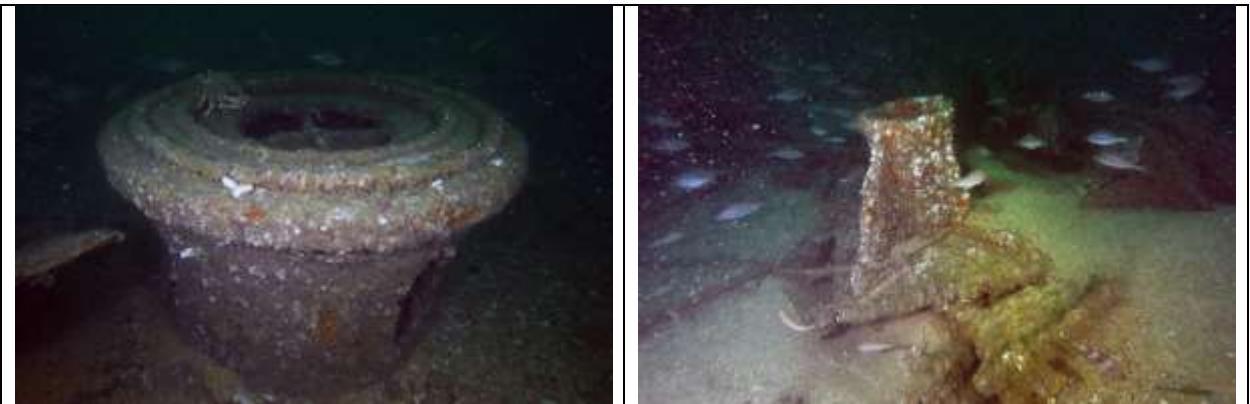
Figure 58 EA3234 Possible gun mountings and davit base. (© Martin Davies)
