TWO TUGS

Report of the investigation of WW2 wrecks reported to be HMRT SESAME and USS PARTRIDGE, Baie de Seine, Normandy, France

> Southsea Sub-Aqua Club | BSAC Branch 0009 December 2019

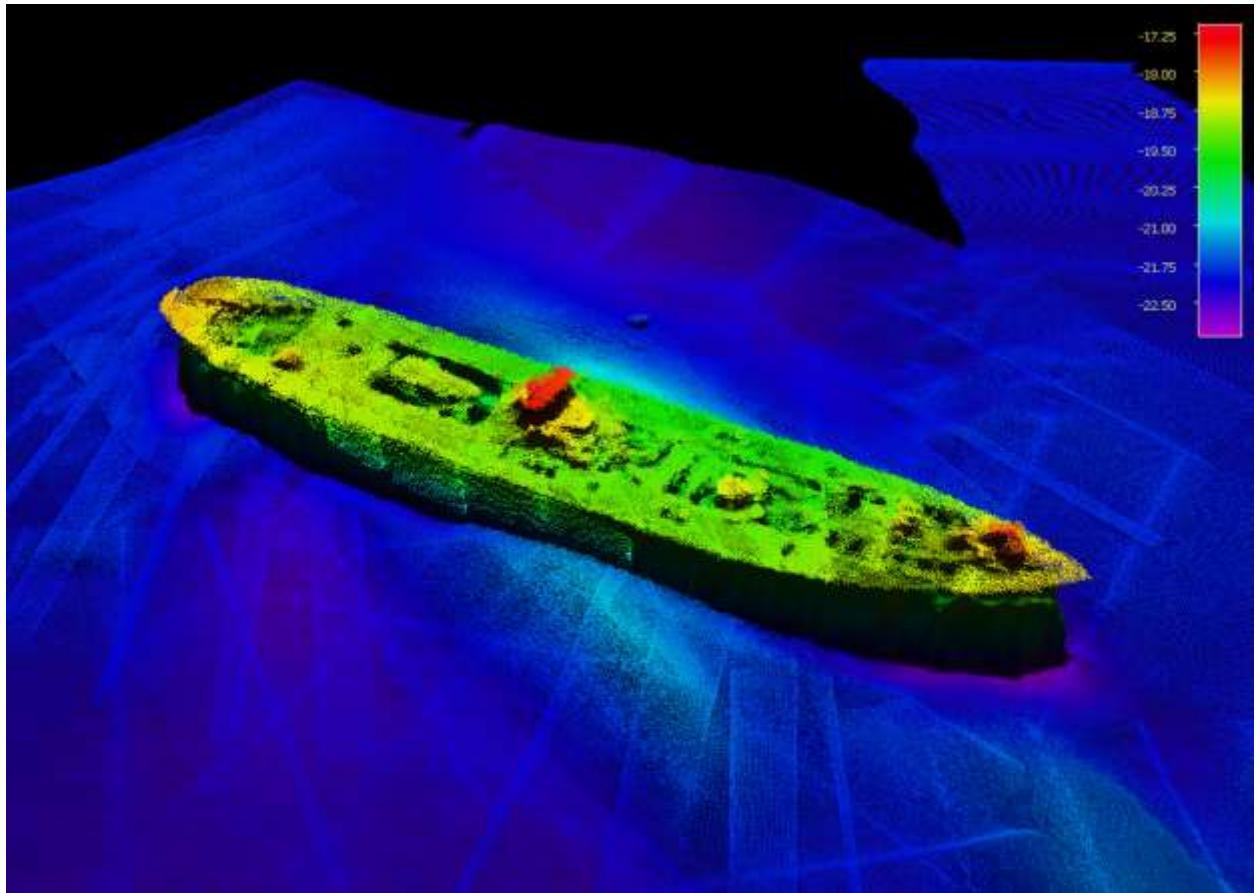
Figure 13 Multibeam sonar image of EA4630 (supposed SESAME) (© DRASSM 2018).

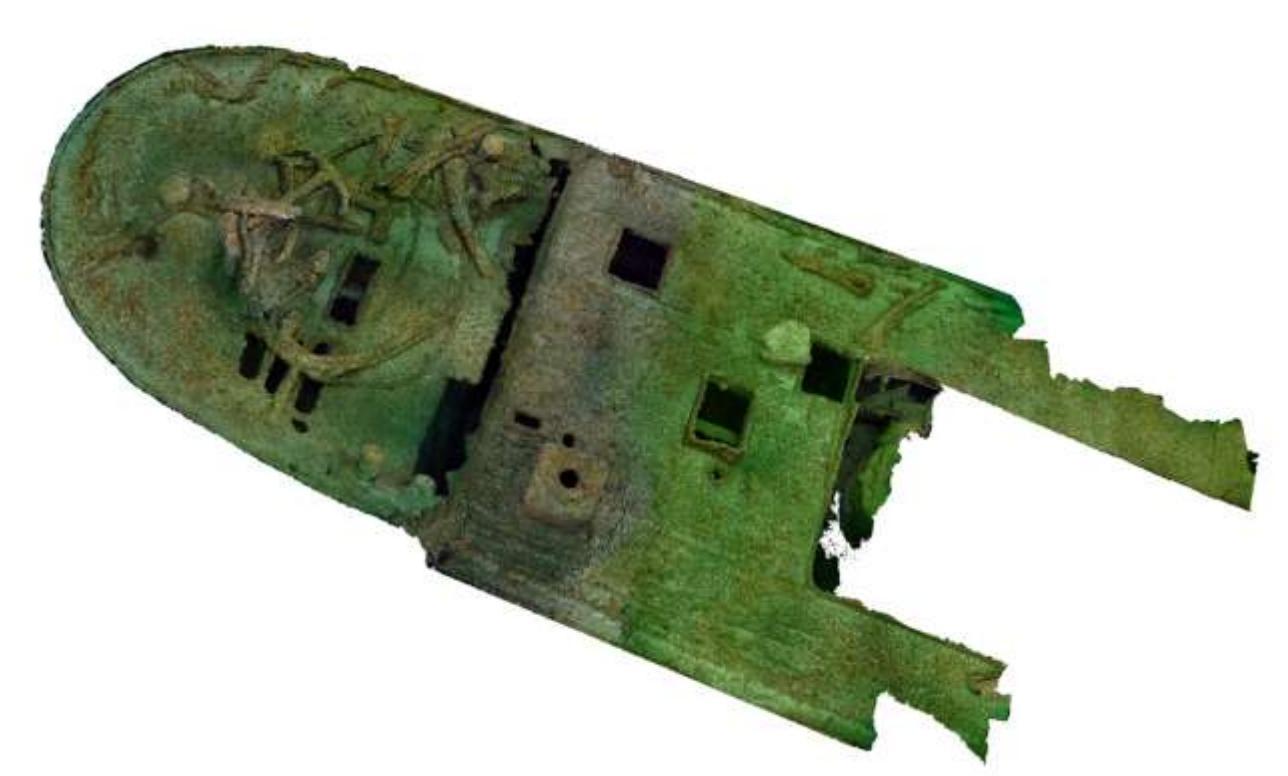
Further measurements and observations were recorded from the engine bay to the stern. It was noted that the wreck had a break in the structure, which was approximately 6m from the stern extending across the width of the deck (6.3m) and partially down the starboard side of the ship.

A photogrammetry model was also produced of the section between the engine and stern area of the wreck. This model clearly shows the break in the wreck structure and collapse of the deck.

Figure 18 EA4630 Image created from photogrammetry model – a plan view of the deck from the engine bay to the stern. Note steering quadrant and anchor. (© Martin Davies)

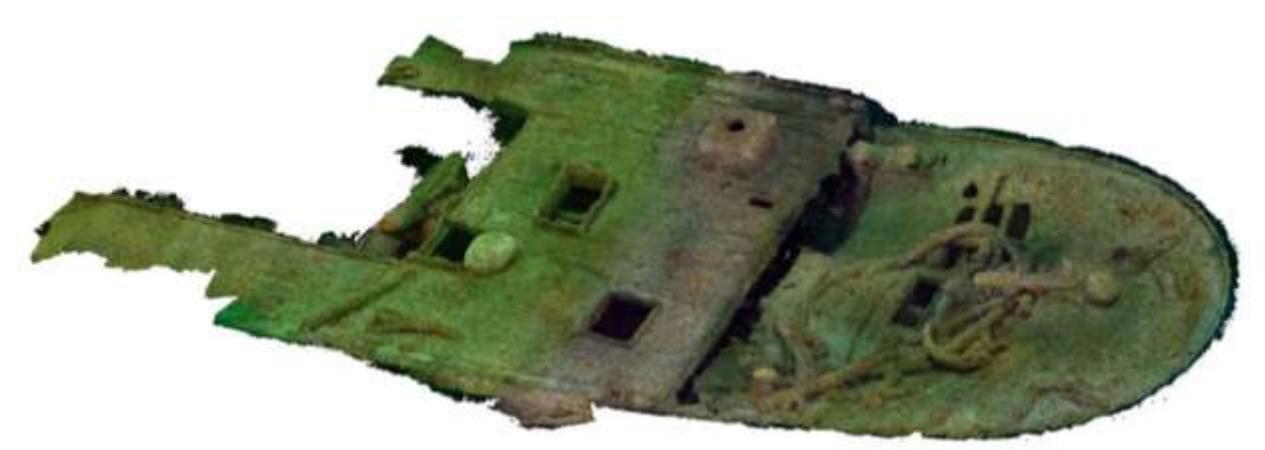
Figure 19 EA4630 Image created from photogrammetry model - stern from the port side showing the collapse of the deck area. (© Martin Davies)

The top of the rudder post and steering quadrant were observed together with an anchor and rope. The damage to the starboard side at the top of the hull was significant, but we could not determine whether this had occurred at the time of the sinking or afterwards. However, given the intact condition of the wreck elsewhere, and this being the only evidence of a breach in the hull's integrity, it may be that the damage was a contributory factor to the sinking.

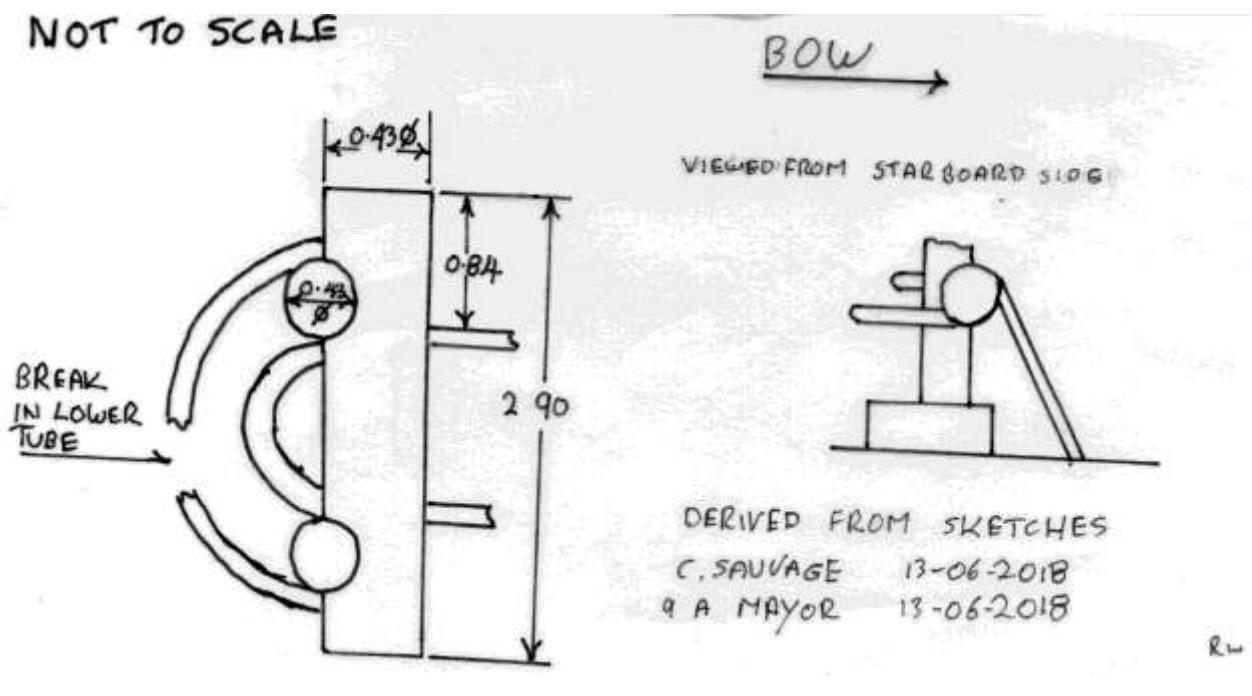
Measurements of the stanchion were taken, which aligned with the data from the previous DRASSM survey data. Part of the rope guide has broken, but otherwise the stanchion remains intact.

Figure 22 EA4360 Drawing of the towing stanchion with measurements taken by DRASSM survey 2018. (© Rob Watkins) A photogrammetry of the stanchion was created and detailed sketch produced.

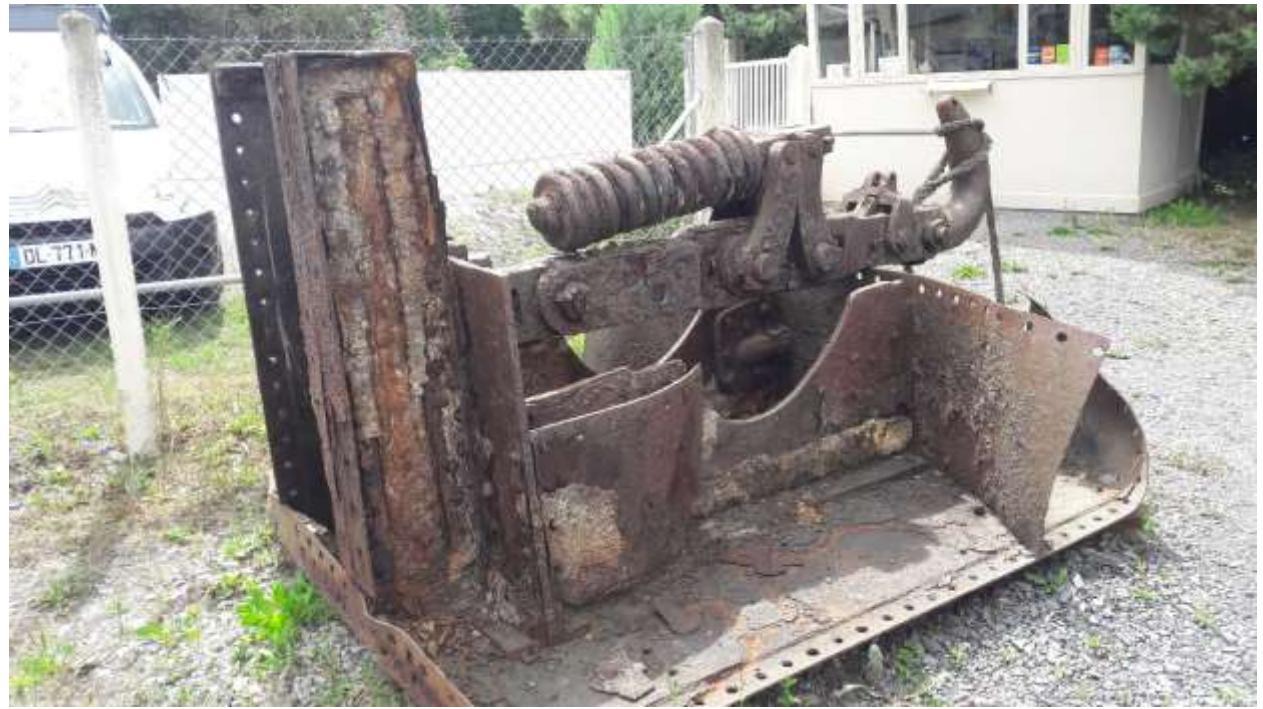
A tow hook was observed at the wreck museum at port-en-Bessin. The exhibit was not labelled and therefore the provenance of the tow hook cannot be established. However, it is likely to be from either HMRT SESAME or USS PARTRIDGE as both tugs had similar tow hook arrangements.

Figure 26 The tow hook exhibited at the wreck museum in Port-en-Bessin. (© Alison Mayor)

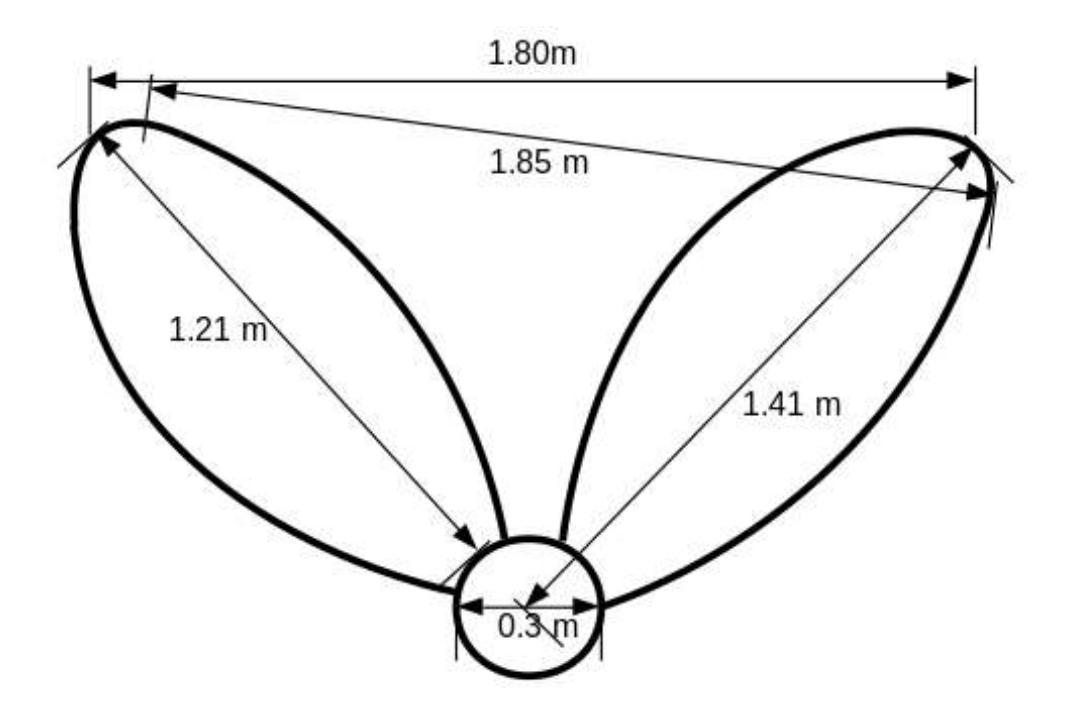
The iron propeller is in situ on the wreck, however one or more of the propeller blades is missing. The propeller was measured during the survey.

Two sets of measurements were taken and used to calculate whether the propeller originally had three or four blades. The lengths of the blades were measured as 1.36m and 1.41m. The distance between the tips of the blades was measured as 1.80m and 1.85m. This variation was due to the curve of the blades, the proximity of the rudder and the considerable marine growth on the propeller.

Figure 29 EA4360 propeller measurements. (© Jim Fuller)

It should be noted that it was not possible to measure between the tips of the blades exactly. A variation of less than 60mm between the tips would have yielded a more exact result of 90 degrees. If the propeller had been three bladed the distance between the tips would have been approximately 2.39m, i.e. more than 0.5m greater than the observed measurements. Thus the conclusion is that the propeller would have originally had four blades.

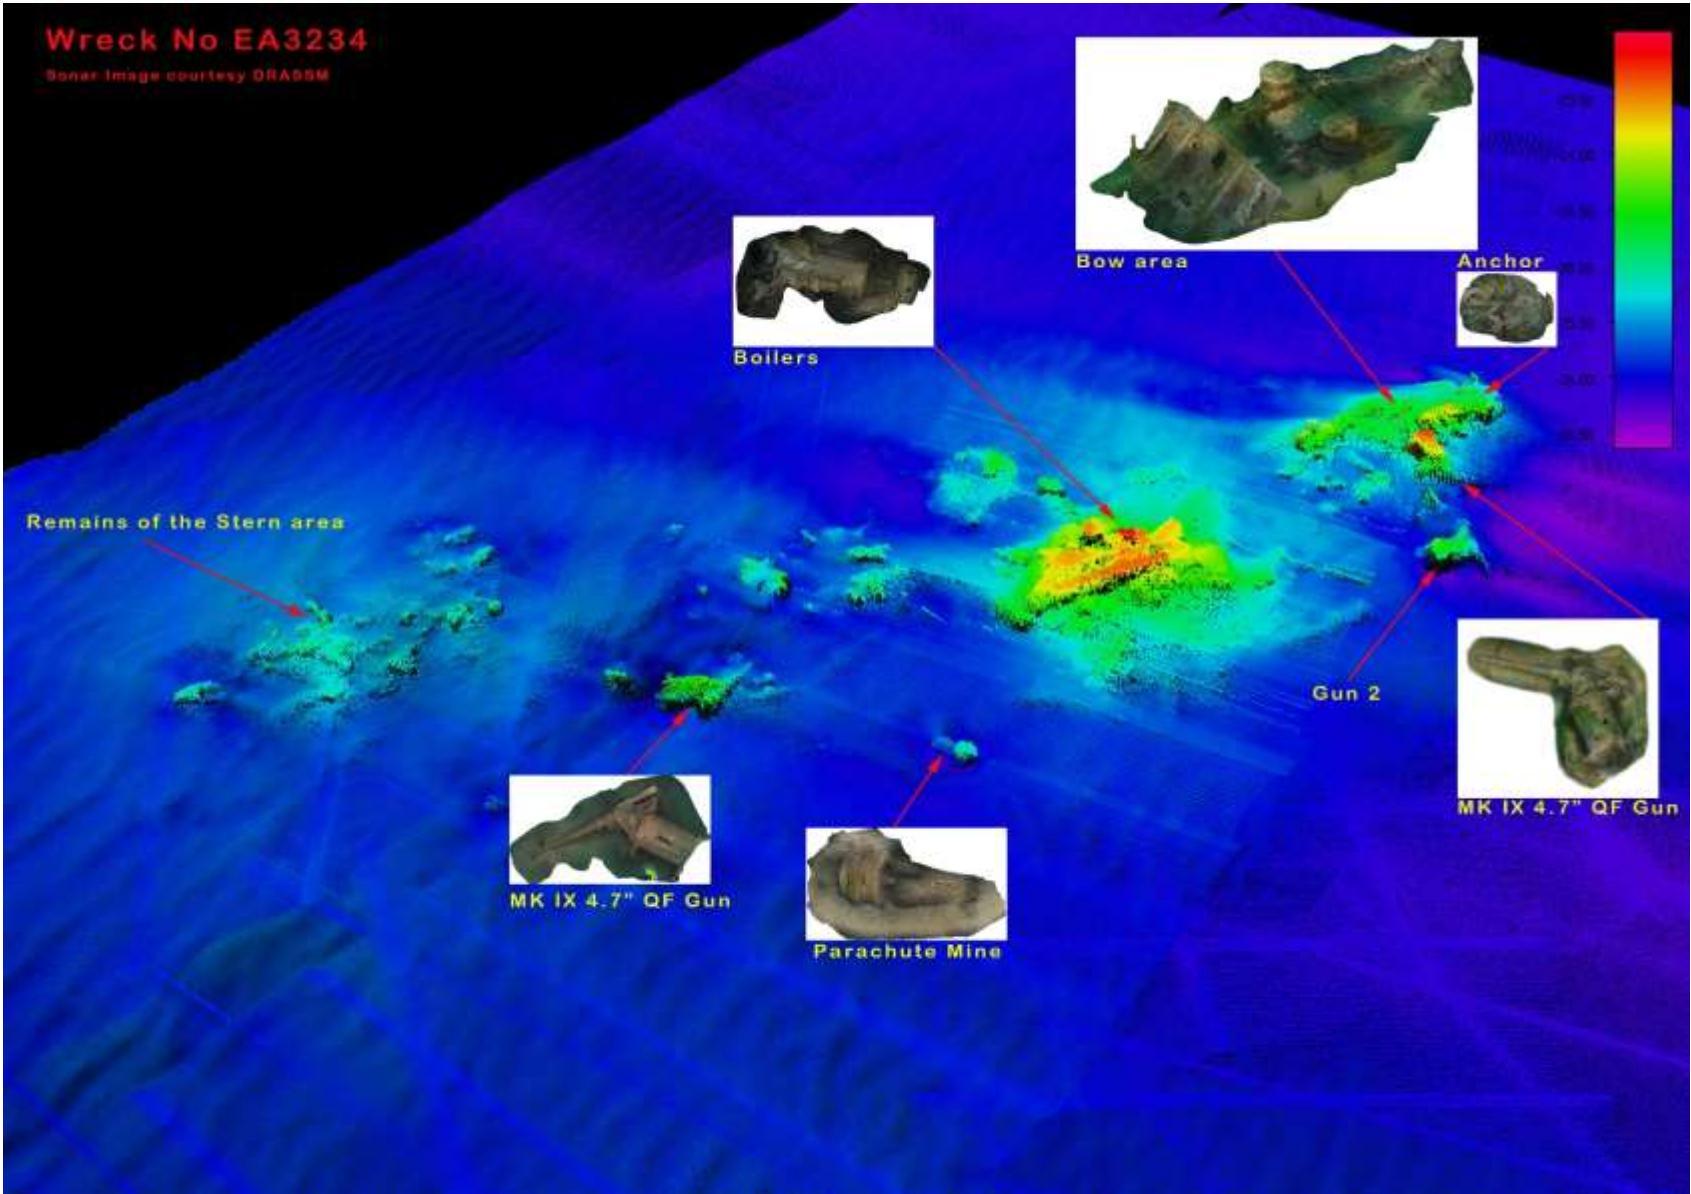
Due to the poor condition of the wreck, believed to be as a result of commercial salvage activity our approach to the survey was to record recognisable features of the wreck. Our survey examined five key areas in order to confirm, or not; the wreck as that of the USS PARTRIDGE. The key features examined were;

Figure 38 EA3234 DRASSM multibeam image showing location of key features. (© DRASSM)

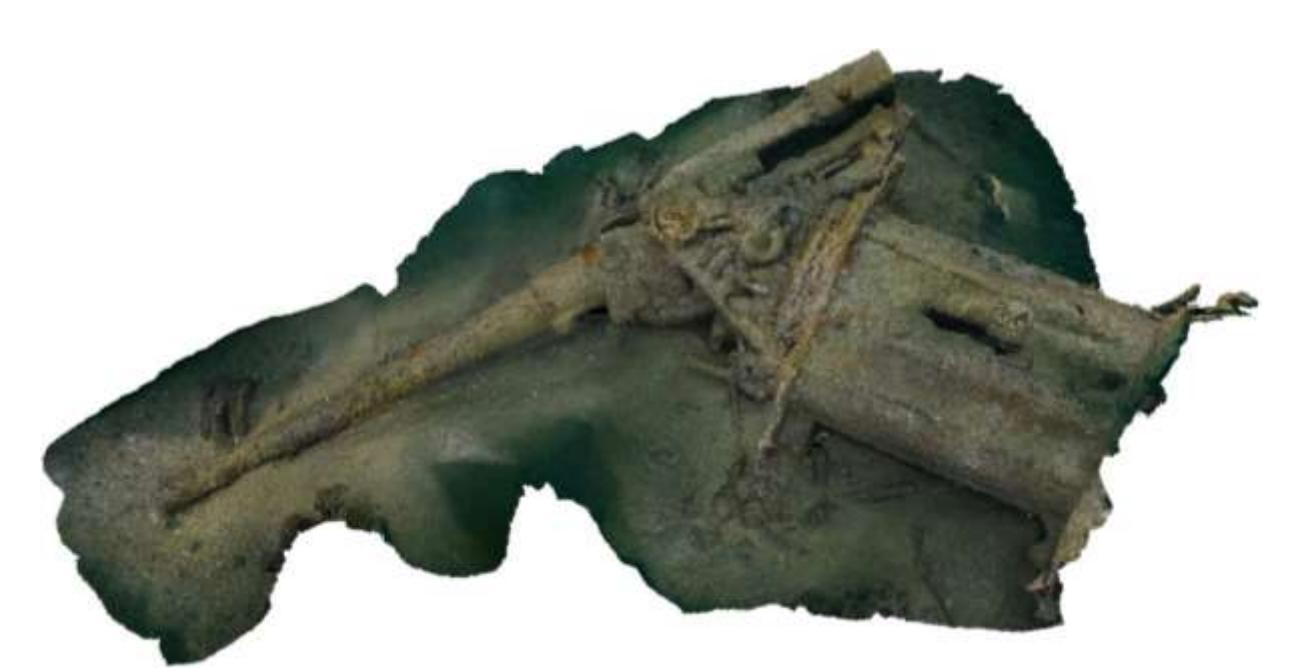
A total of three breach loading guns were found on the site; two guns behind the bow and one after the boiler section to the west.

Figure 45 EA3234 Plan view of Gun 3 (© Martin Davies)

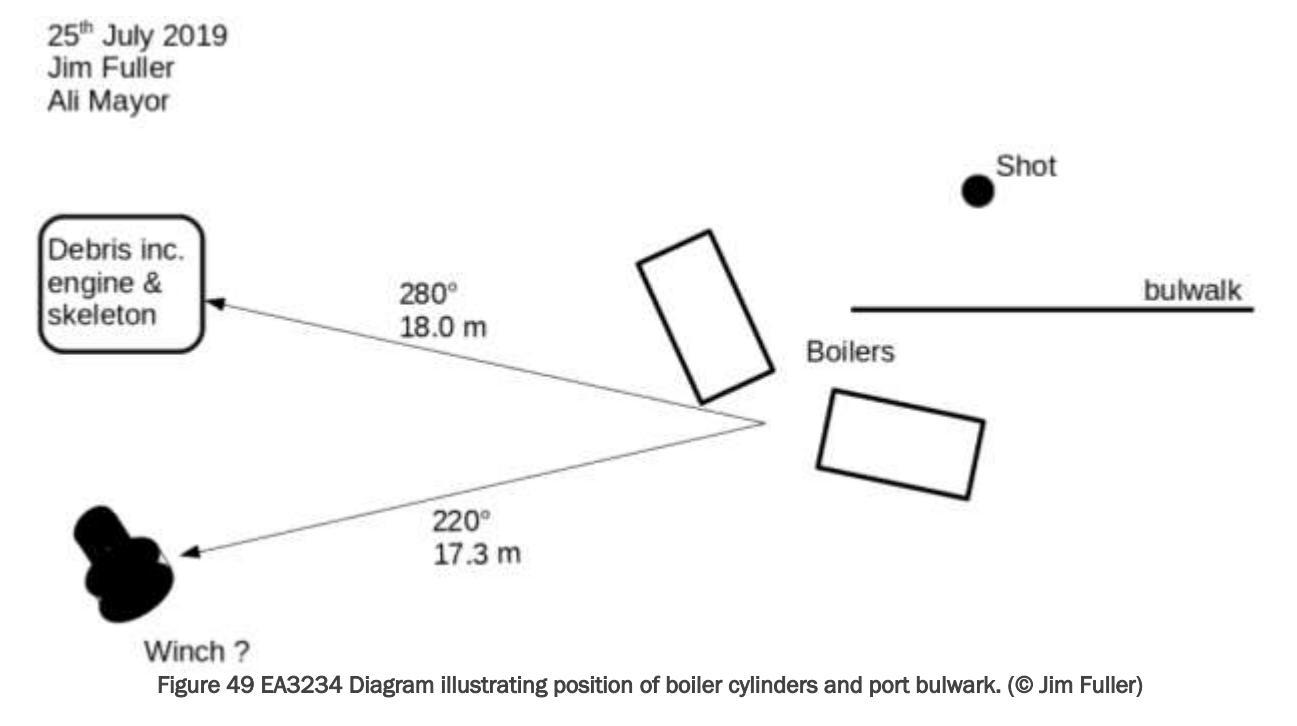
To the West (220 degrees) we found a circular object (described in the image below as a winch) which we believe may also be part of a turbine assembly.

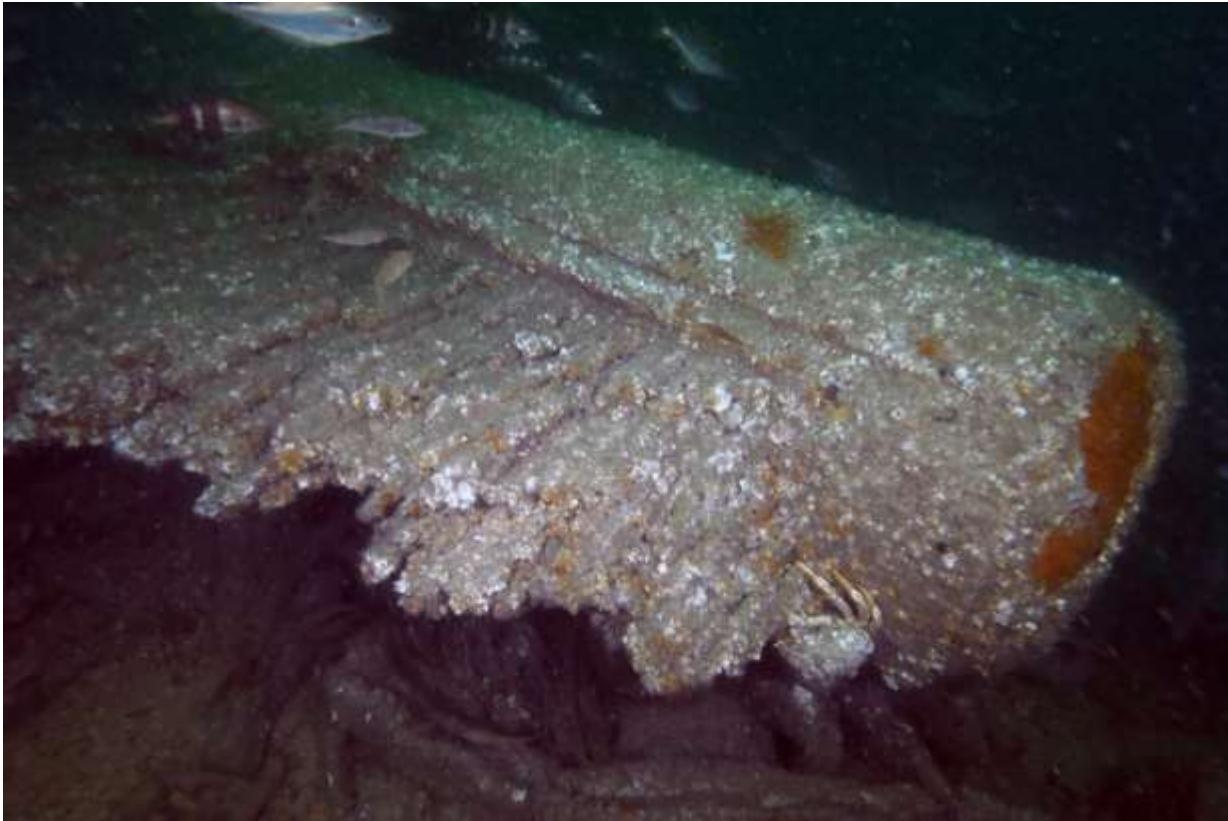
The highest part of the wreck is where the remains of the ship's steam boilers are located. We observed two cylinders surrounded by many lengths of broken pipes. The larger of the two cylinders had pipes extending vertically and the other, smaller cylinder, on its side, had pipes that extended horizontally. The boiler assemblage was very broken possibly as a result of salvage activity.

Figure 52 EA3234 the smaller boiler cylinder (water) with horizontal pipes. (© Martin Davies)

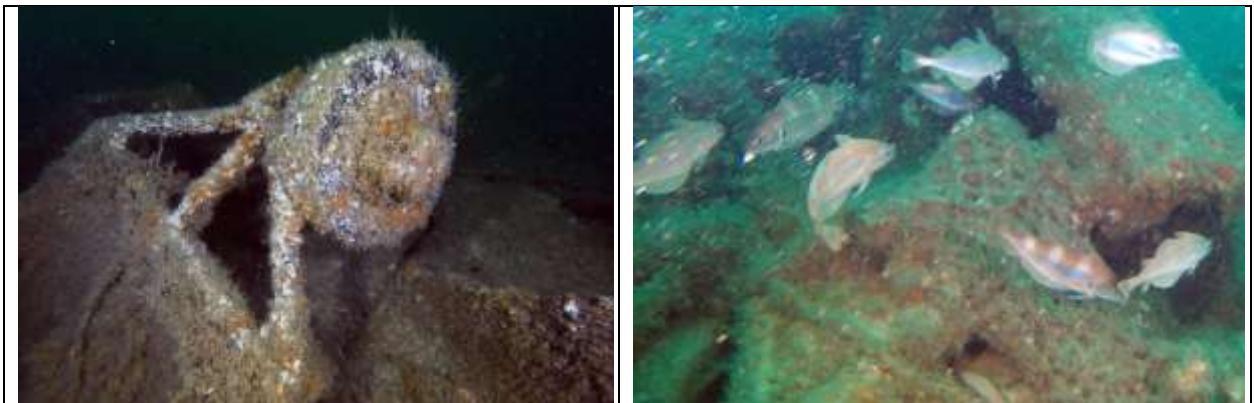
There was a substantial amount of trawler equipment present on the wreck, especially around the north west of the boiler area and gun 2.

Figure 59 EA3234 Trawl gear and netting (© Martin Davies) and (© Alison Bessell)

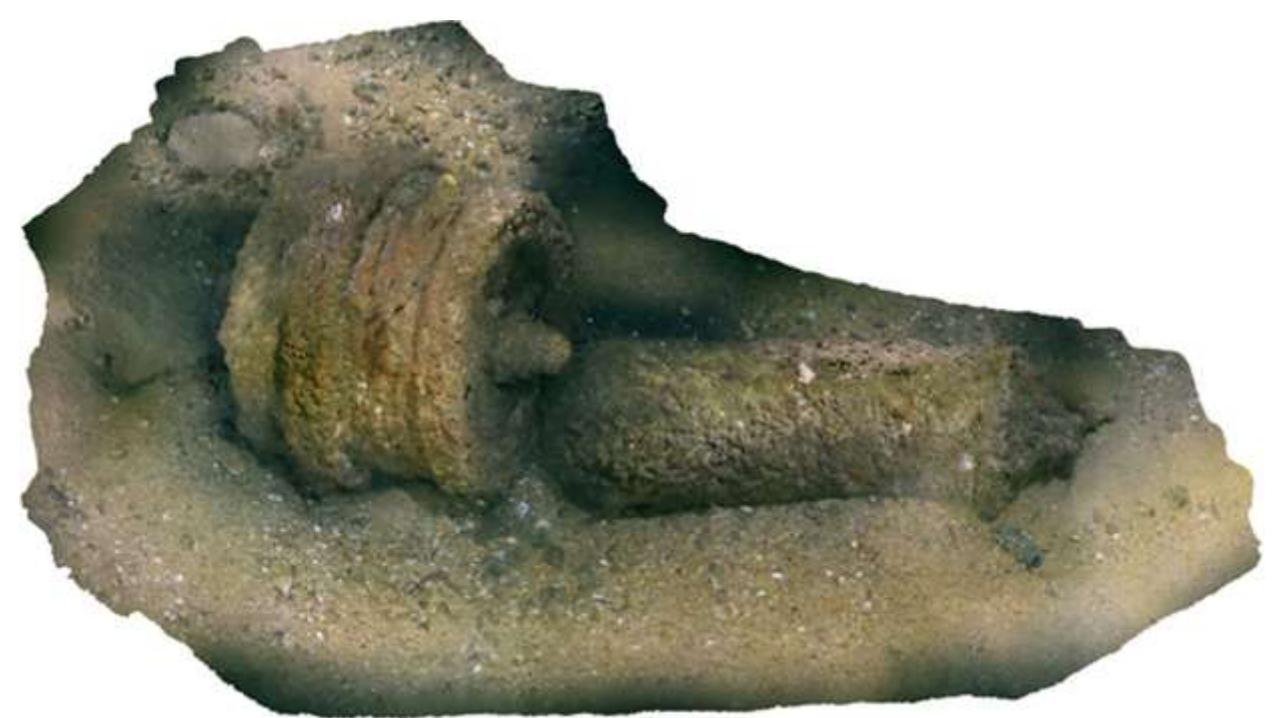
Towards the south west of the boilers we located two objects that were close together and our initial thought was that the two items were part of the same object. We considered it may be part of a turbine assembly.

Figure 60 EA3234 Mine like object (German Parachute Mine) and possible turbine assembly. (© Martin Davies)

Further investigation, some weeks later, and having visited the wreck museum at Port-en-Bessin, we realised that one of the objects may be a mine like object. The museum has a display of an inert German mine which closely resembled the artefact on the right hand side of the above image.

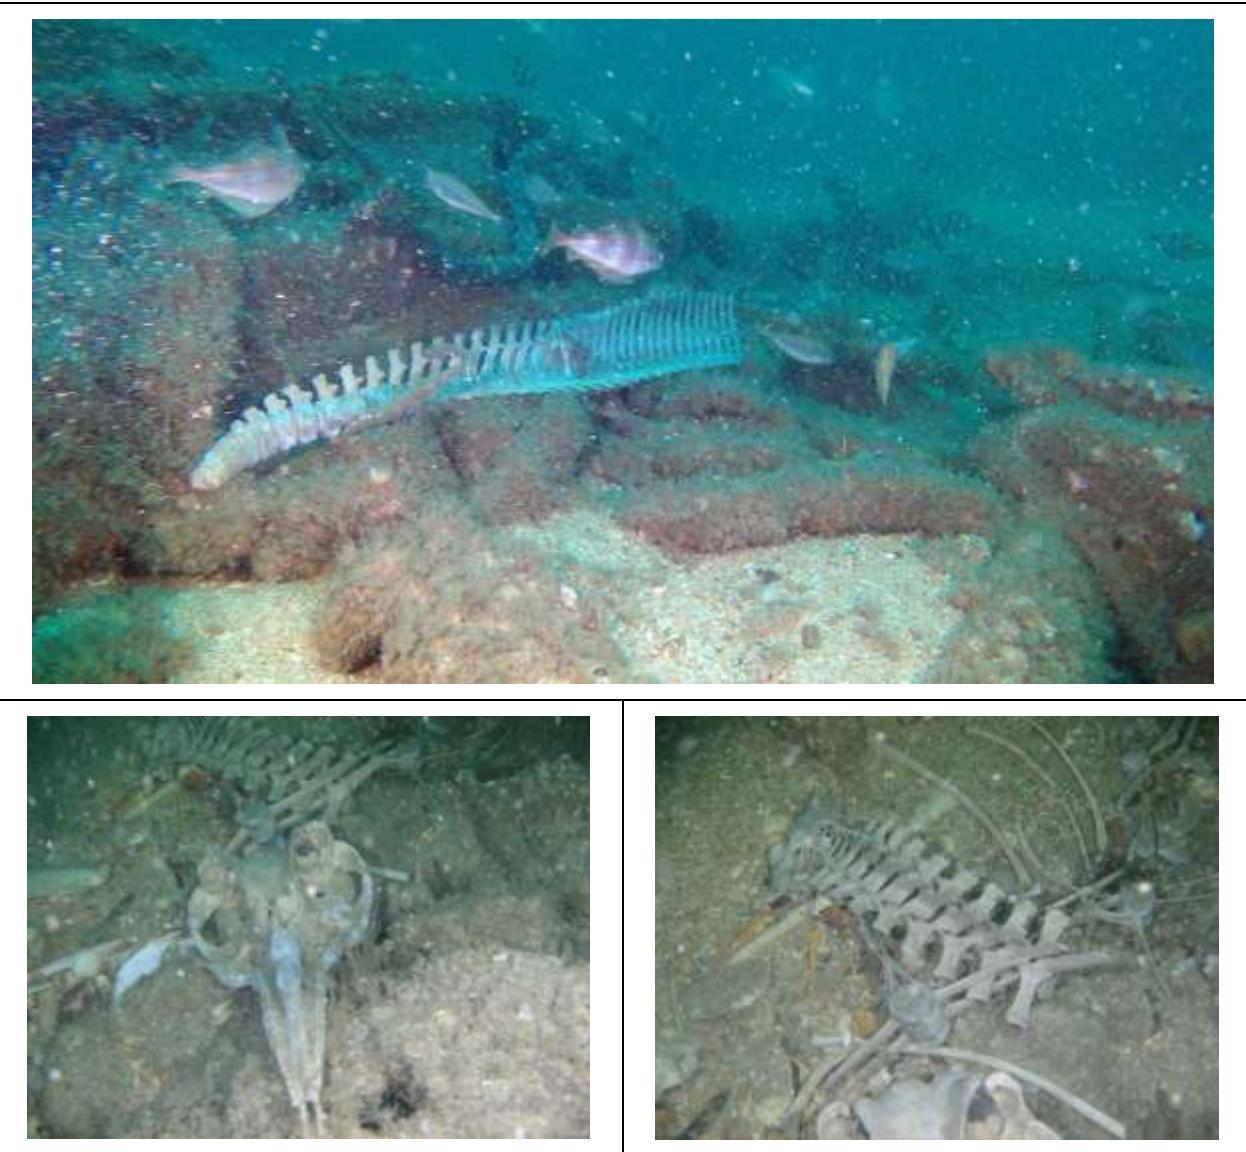
Figure 85: Skeleton of small dolphin on the 'USS PARTRIDGE'

On the supposed wreck of the USS PARTRIDGE EA3234, an unusual sight was the skeleton of a marine mammal, believed to be a small dolphin. Towards the end of the survey, recent storms had started to disperse its remains.

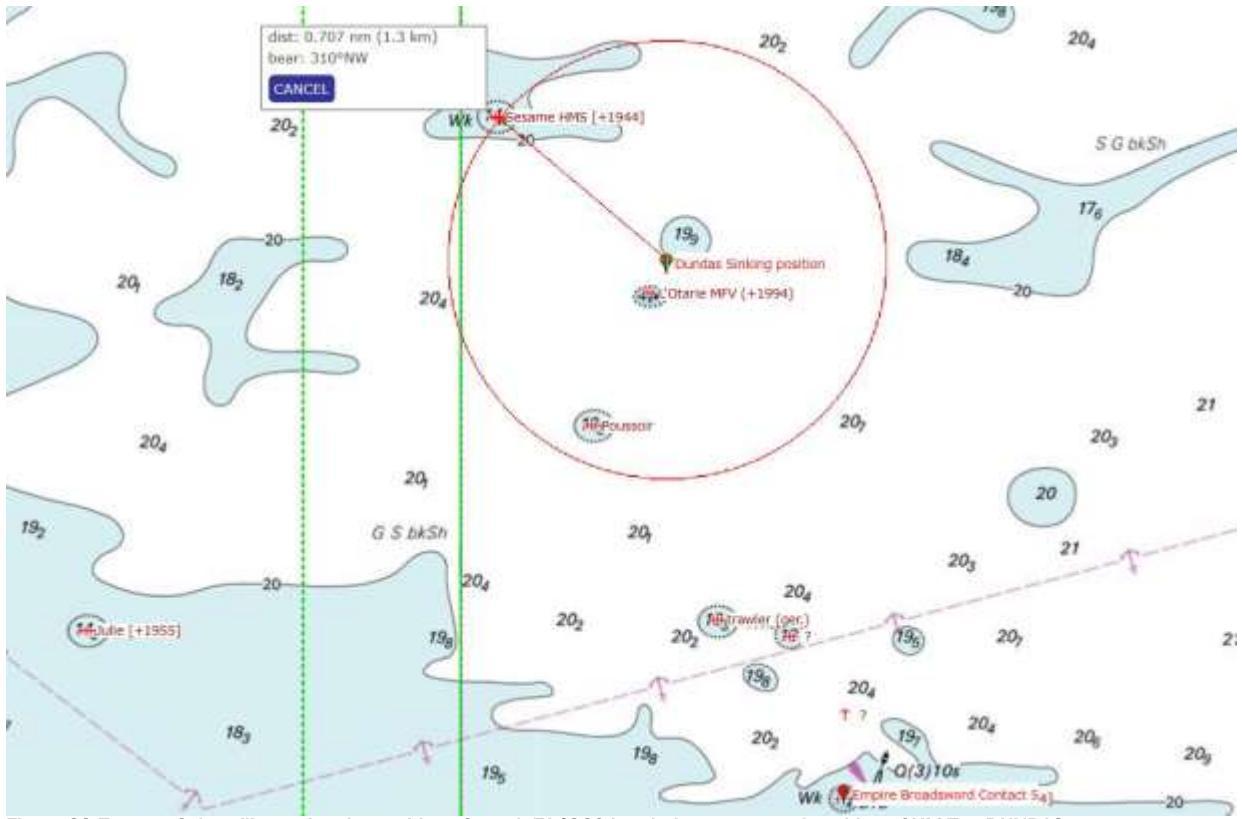
Figure 89 Extract of chart illustrating the position of wreck EA4360 in relation to reported position of HM Tug DUNDAS.

Observation 1 Assuming that the wreck EA4360 is that of HM Tug DUNDAS, the report by her master could explain why propeller blades were missing/damaged. It may also indicate that much of the damage was at the keel and therefore not visible.

Observation 2. The position reported by USS BANNOCK of the wreck of HM Tug DUNDAS is approximately 0.7 Nm (1.3Km) from the wreck EA4360.

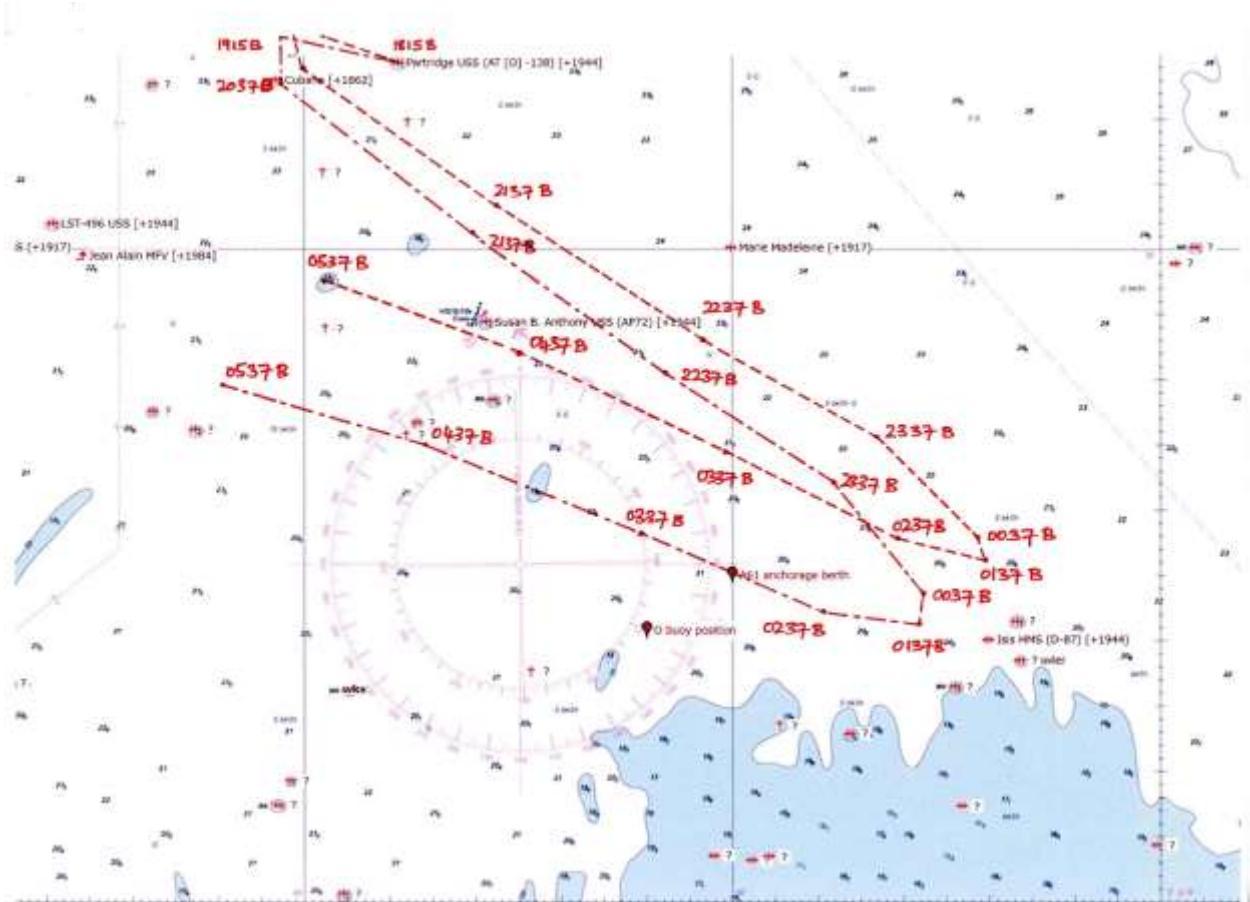
Figure 92 the estimated track of survivors from HMS ISIS survivors based on weather (wind) and tidal movement on 20th - 21st July 1944. (Tom Templeton)

Observation 5 the drifting pattern of survivors from HMS ISIS is consistent with the ship sinking at the location EA3234.

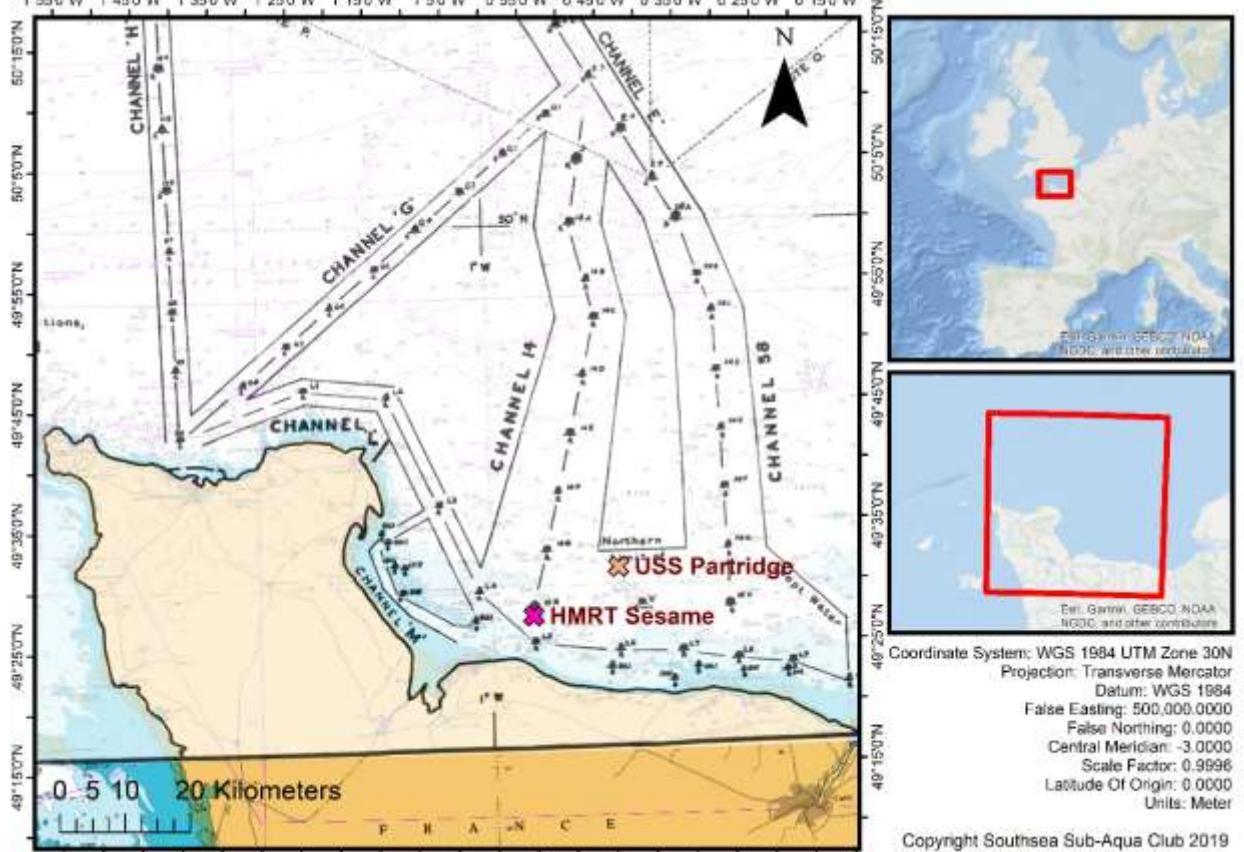
Figure 94 overlay image of swept channels and position of wrecks EA4360 (supposed SESAME) and EA3234 (supposed PARTRIDGE)

The above image illustrates the significant variation between the reported loss and the wreck sites.

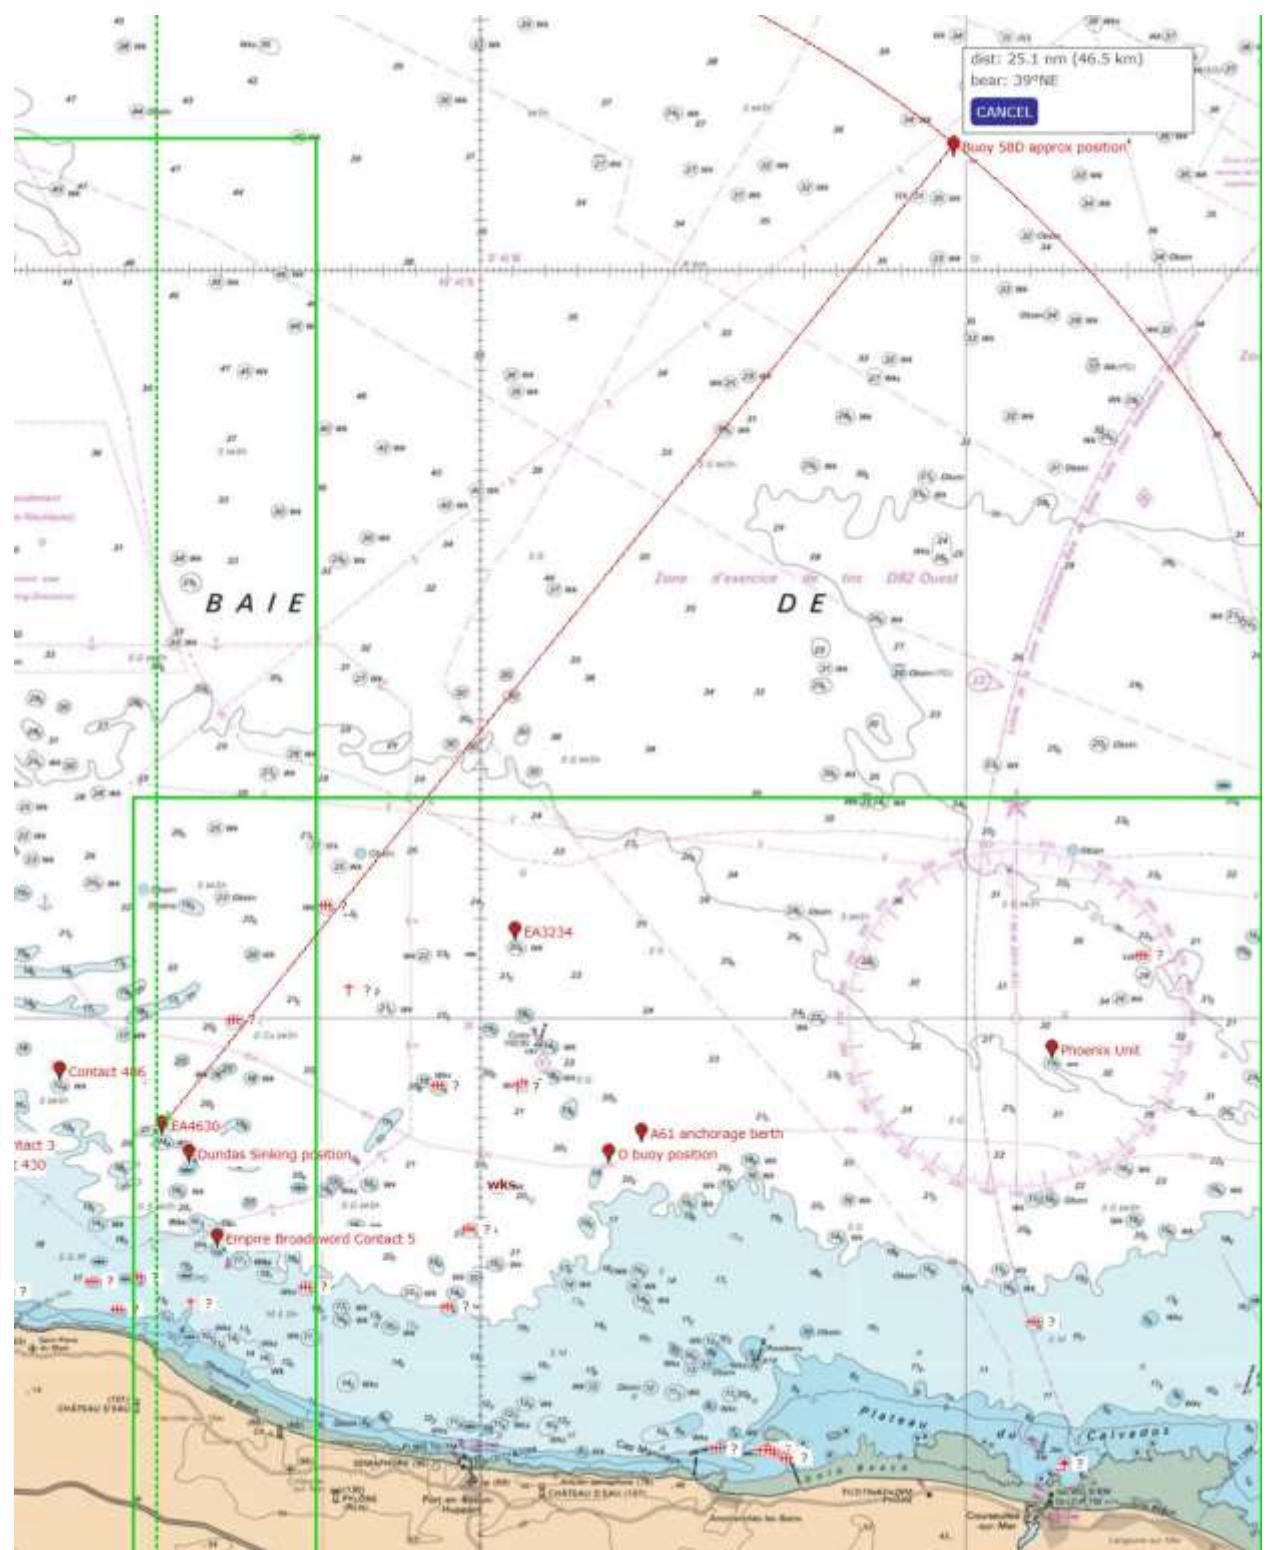
Figure 95 Position of EA4630 (supposed SESAME) from estimated position of '58D' buoy.

Site EA4360 (supposed SESAME) is 25.1Nm (46 km) distance from the estimated position of 58D buoy.

Observation 7 the position of the wrecks EA4360 and EA3234 are too far from the reported loss of HMRT SESAME and USS PARTRIDGE; being in the vicinity of 58D buoy.

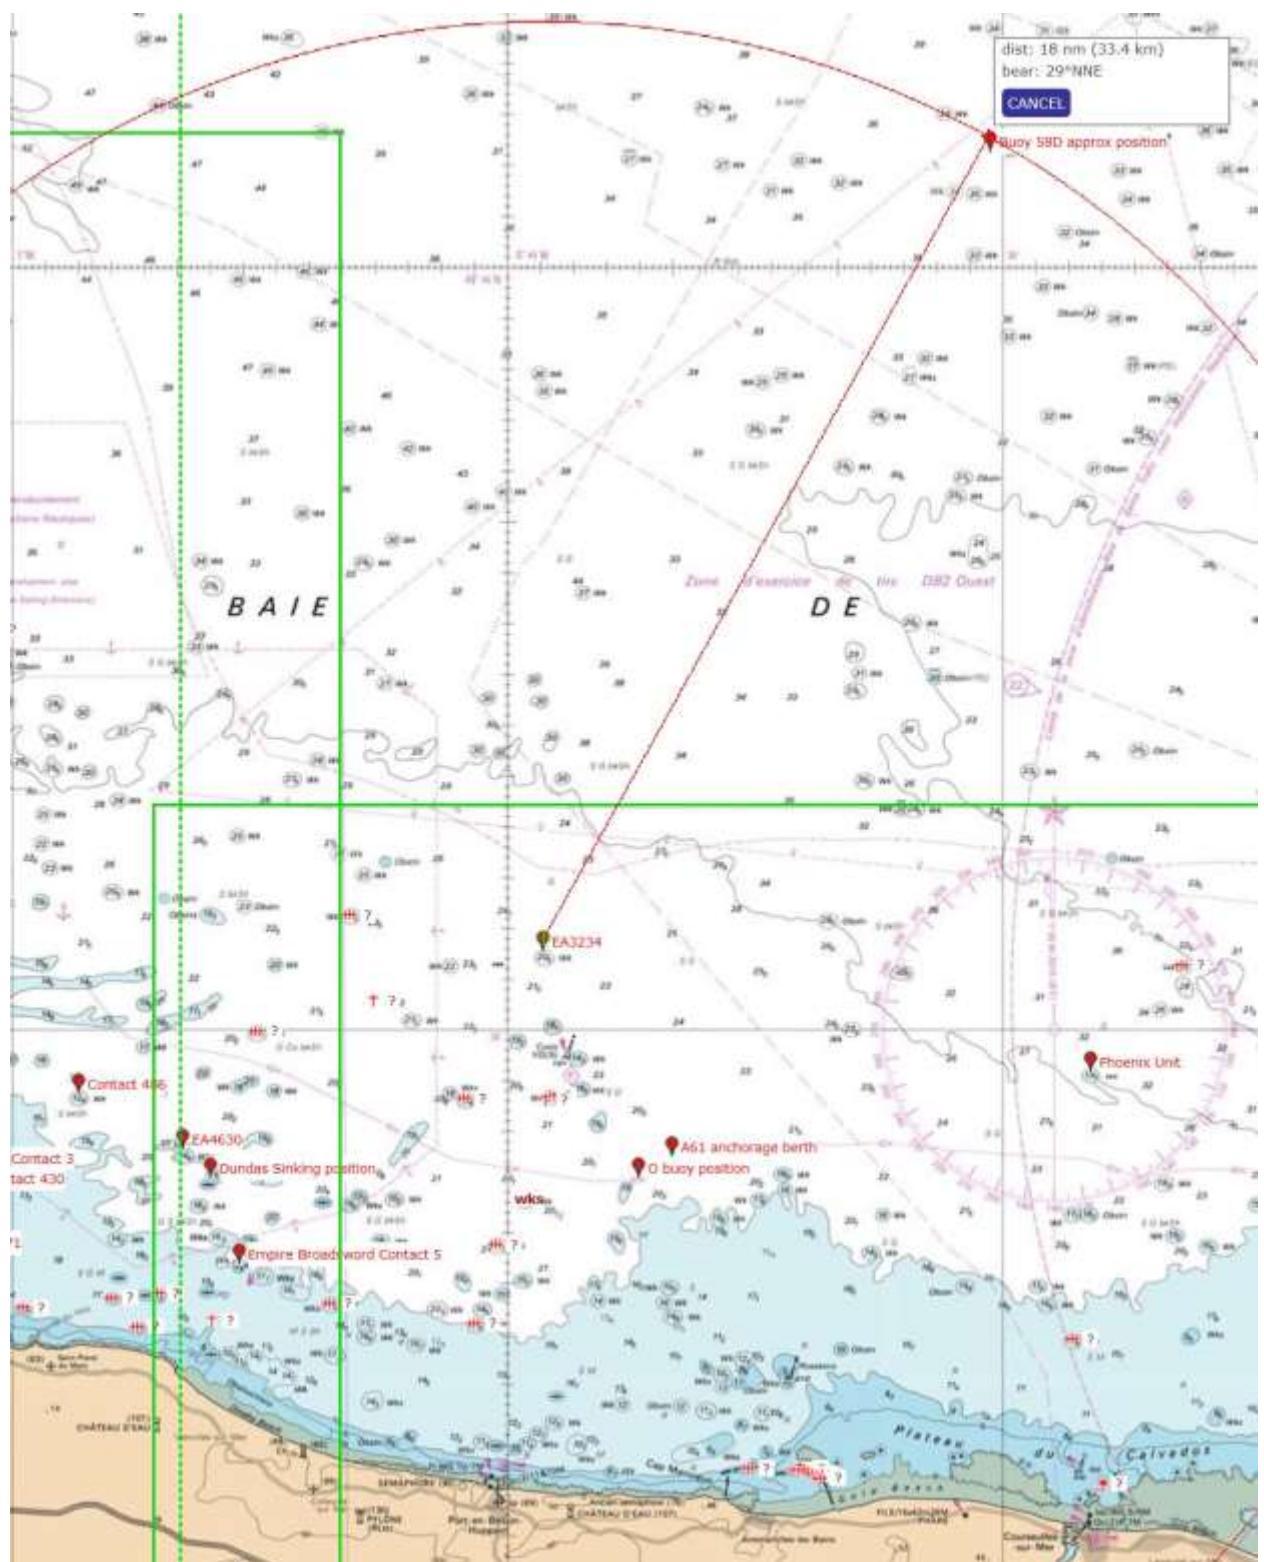
Figure 96 Extract from chart showing position of EA3234 (supposed PARTRIDGE) from the estimated position of 58D buoy. EA3234 (supposed PARTRIDGE) is 18Nm (33.4km) distance from 58D buoy.
